# IMAGERY DATASET FOR REMAINING USEFUL LIFE ESTIMATION OF SYNTHETIC FIBRE ROPES

A PREPRINT

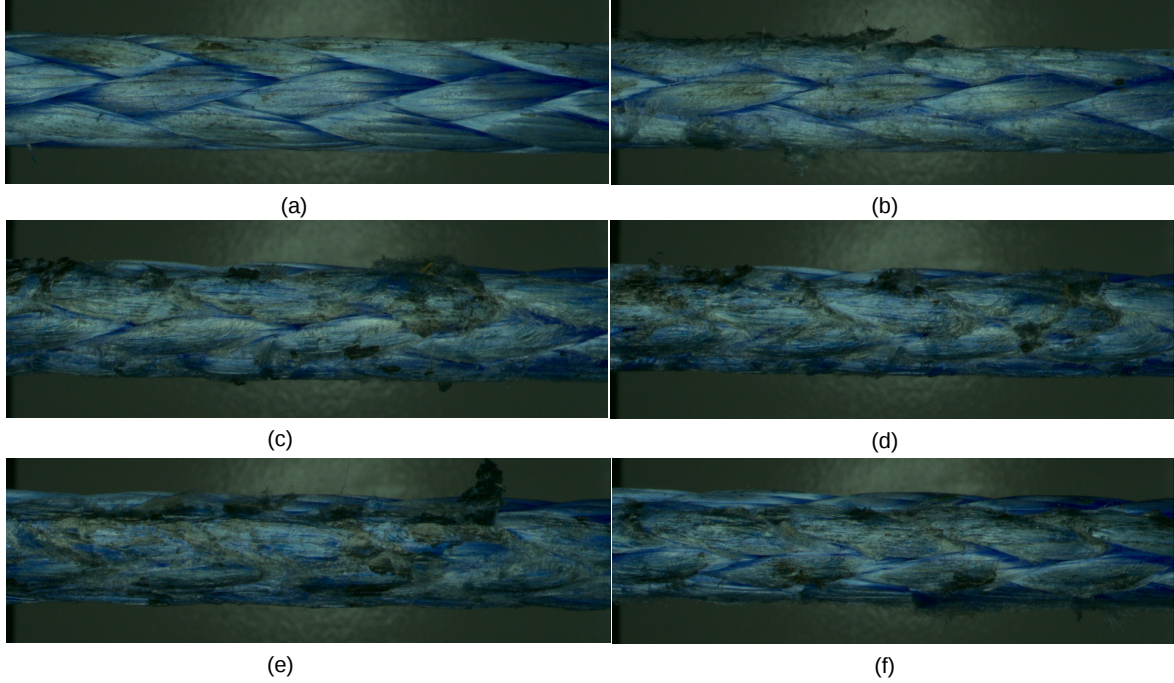
Figure 1: Lifecycle images for rope specimens from healthy condition (a) to failure (f), illustrating the accelerating rate of visual degradation.

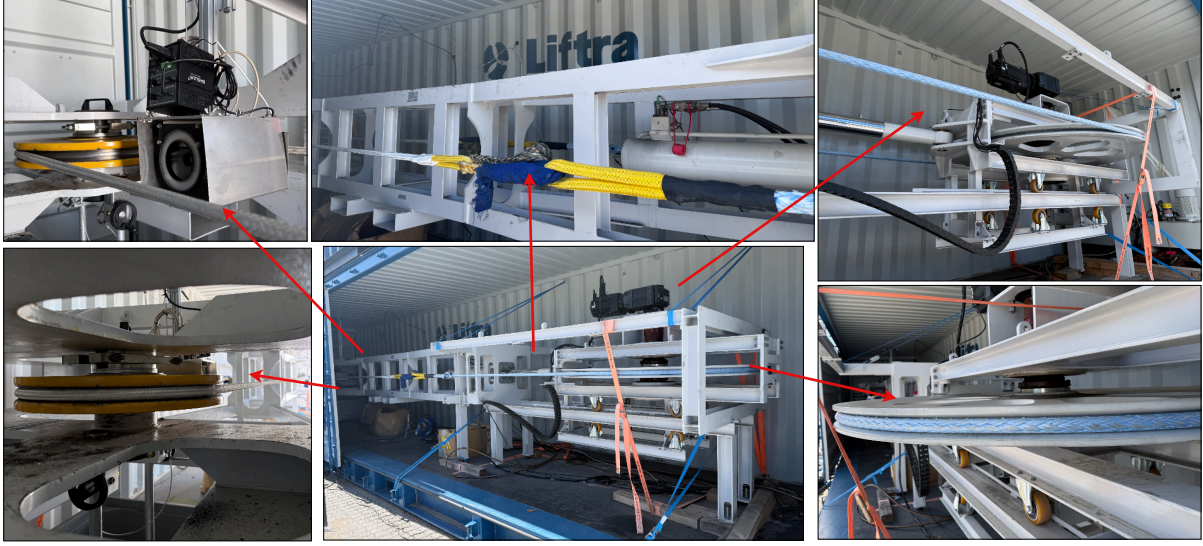
Figure 2: Sheave-bend fatigue test stand (lif [2026], dyn [2026]) used for cyclic loading of Dyneema SK75/78 HMPE rope specimens. The central image shows the full test frame with the rope specimen installed under axial tension. Surrounding close-up views highlight: (top-left and bottom-left) the camera unit and sheave assembly showing the rope bending contact zone; (top-centre) the rope specimen under load with visible colour-coded strand markers; (top-right and bottom-right) the multi-sheave pulley arrangement and rope routing path; (bottom-centre) the complete test stand assembly housed within the test container facility.

Rope specimens were subjected to cyclic fatigue on a sheave-bend test stand. An axial tension load was applied to the rope while the sheave rotated back and forth, bending the rope over the pulley in a repeating cycle. This BOS loading regime replicates the primary failure mechanism experienced by hoisting and crane ropes in operational service. After completion of the selected sheave cycles, rotation stopped, and ten images were taken of different cross-sections along the rope length. Taking ten images at different positions provides a spatially representative sample of rope condition, since fatigue damage is not spatially uniform. These ten images constitute one inspection burst; all images within a burst share the same elapsed cycle count and therefore receive identical RUL labels. Testing continued until each rope failed completely. Illumination was provided by the Aputure AL-MC RGBWW LED lights positioned at approximately 45° to the rope surface to provide uniform, shadow-free lighting across the rope cross-section during image capture. Image acquisition was managed by an NVIDIA Jetson Nano P3450 embedded computing platform, which interfaced with the camera system and triggered burst capture at the specified cycle intervals.

Images were acquired using a Basler acA2000 GigE Vision camera connected via Ethernet, fitted with a Basler C11-5020-12M-P Premium 12-megapixel lens at a resolution of 1920 × 1200 pixels. The camera operated in continuous acquisition mode with software triggering at an exposure time of 5000 µs, with auto-exposure disabled to ensure photometric consistency across all images and all rope specimens. Raw frames were captured in BayerRG8 pixel format and converted to BGR8 prior to PNG storage. Strobe synchronisation between the camera exposure and the Aputure AL-MC RGBWW LED lights was achieved by configuring the camera output as a strobe signal, ensuring the lights fired precisely and exclusively during each exposure window, eliminating ambient light variation between frames. Image
