# Cracking under pressure — investigating mitigation approaches for silicon fractures on ATLAS strip tracker petals at cold temperatures

For the High-Luminosity upgrade of the Large Hadron Collider, the ATLAS experiment will replace its current Inner Detector with an all-silicon Inner Tracker (ITk), consisting of pixel and strip detectors. The strip detector will consist of a central region or “barrel” assembled with staves and forward regions or “end-caps” assembled with petals. The ITk will nominally operate with liquid CO<sub>2</sub> cooling at  $-35^{\circ}\text{C}$ ; however, in the event of cooling system failures, it is possible that sensors will experience temperatures below  $-35^{\circ}\text{C}$ . At these low temperatures, it has been observed that the silicon sensors within modules — the fundamental readout units of the detector — can physically crack, rendering the modules inoperable. Understanding and resolving the issue of sensor cracking was one of the most important and urgent issues for the ITk project. This paper presents part of the mitigation strategies developed for petals. These mitigation strategies are based on modifications to the choice of adhesive and i

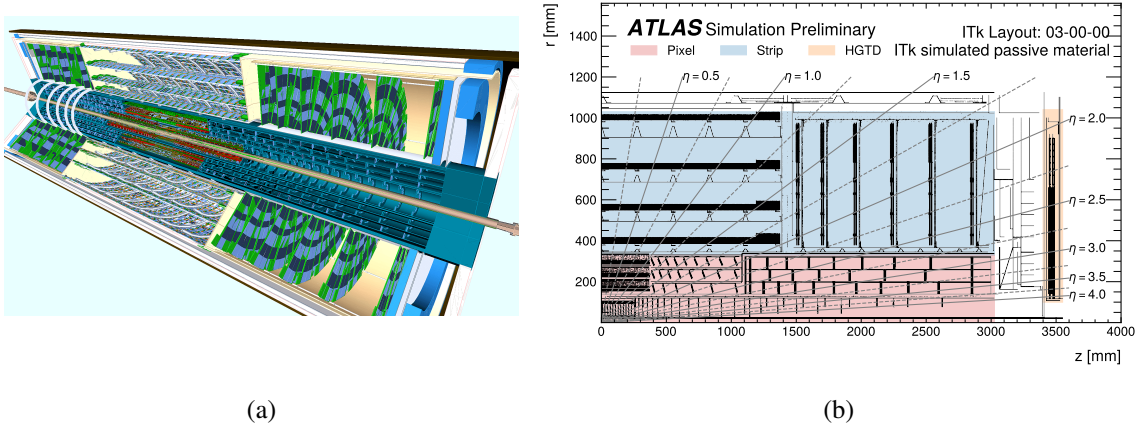
**Figure 1:** (a) Visualization of the ITk including the inner pixel detector and outer strip detector [8]. (b) Schematic overview of one quadrant of the ITk with the pixel system in red and the strip system in blue [14]. The horizontal axis is parallel to the beam line with the origin at the interaction point, and the vertical axis is the perpendicular radius from the interaction point.

The ITk is pictured in figure 1a: it is composed of a pixel detector [7], located closest to the beam line, and a strip detector [8] surrounding the pixel detector. The strip detector consists of a barrel region with four cylindrical layers and two end-cap regions each with six disks, as shown in figure 1b. The strip detector is built of two local support structures: staves for the barrel region and petals for the end-cap regions [9]; this paper will focus on petals. A petal, seen in figure 2, is made of a carbon-fibre core of a radial shape. Copper-on-polyimide bus tapes on the surface of the core route data and power. Titanium pipes embedded within a thermally-conductive foam comprise the interior of the core and provide cooling down to  $-35^\circ\text{C}$ . The petal is double sided, with a main side and a secondary side. Twelve silicon modules [10, 11] — the fundamental readout units of the strip detector — are glued or “loaded” onto the core, six on each side, using an automated assembly system [12]. The automated assembly system is capable of dispensing adhesive and placing modules with micron-level precision. The End-of-Substructure (EoS) cards [13] on a petal serve as the interface between the modules on that petal and the off-detector systems.

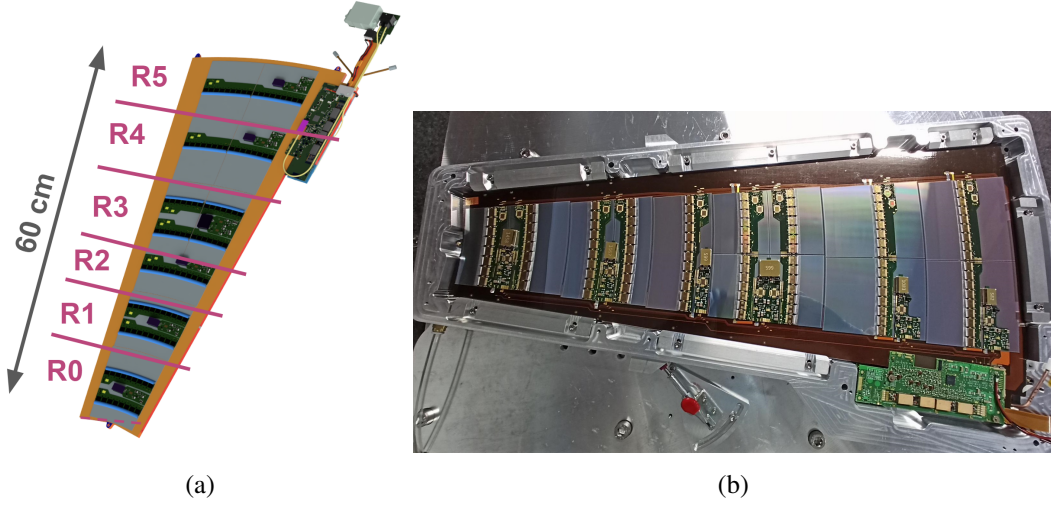
**Figure 2:** (a) Schematic of petal with the different module types (R0–R5) delineated [15]. (b) Picture of a loaded petal.

Owing to the radial shape of the petal, each of the six modules on a single side is of a unique type and labelled R0 through R5 in order of increasing radius. The module types offer the same functionality and differ only in their geometry. A schematic of a module is shown in figure 3a. Each module consists of one or two silicon strip sensors [16], onto which are glued printed circuit boards (PCBs) known as hybrids and powerboards [17]. The hybrids perform readout via front-end ATLAS Binary Chips (ABCs) [18] and control via Hybrid Control Chips (HCCs) [19]. The powerboards provide low voltage (LV) — accomplished using a DC-DC converter — and high voltage (HV) to the readout electronic and sensors, respectively, and monitor conditions via Autonomous Monitoring and Control chips (AMACs) [20]. The design of the hybrids and powerboards also vary for each module type to adapt to the geometry. Each module has between one and four hybrids of different types, labelled H0 through H3.<sup>1</sup> On modules with two physical sensors or “split” modules — R3, R4, and R5 modules — the right and left halves are labelled by M0 and M1, respectively.<sup>2</sup> Modules undergo extensive quality control (QC) [21]. Of particular importance is the ability to reach an HV bias voltage of  $-500\text{ V}$  with sensor leakage current and noise performance within acceptance criteria (described in section 2.1).

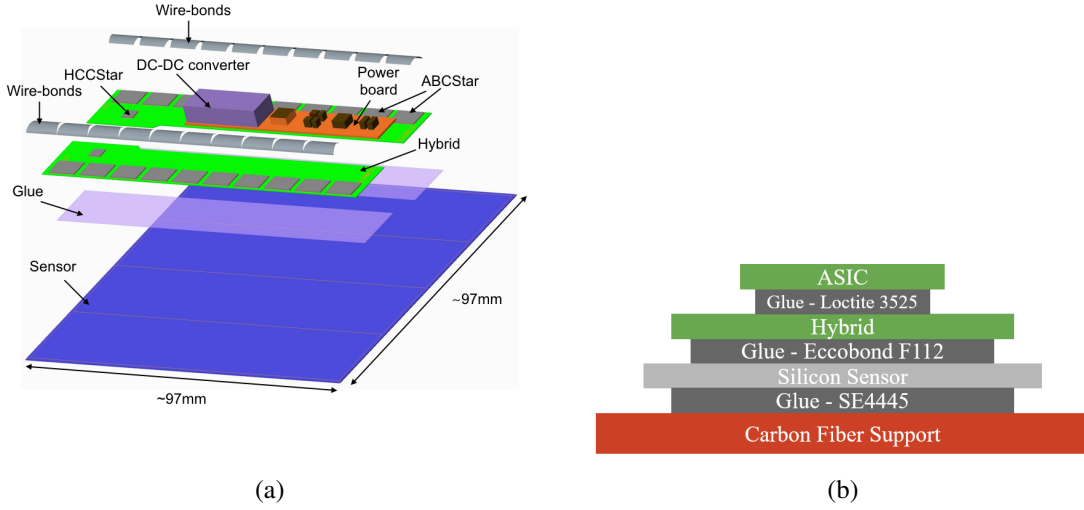
under and between PCBs. Simulations of the detector [23] suggest that cracks are caused by a mismatch in the coefficients of thermal expansion (CTEs) between the copper-based PCBs and the silicon sensor. A cross section of a loaded module is shown in figure 3b. A silicone gel, SE 4445 CV (“SE4445”) [24], is used below the sensor and a stiff adhesive, Eccobond F112 [25], is used to attach the PCBs directly onto the silicon sensor. This combination leads to areas of mechanical stress within the sensor at cold temperatures, where the copper inside the PCBs contracts more than the silicon, resulting in cracks. Dedicated measurements have shown that the majority of sensors only crack for stresses above 350 MPa, but outliers can show cracks at 200 MPa and extreme outliers can show cracks as early as 100 MPa [26].

**Figure 3:** (a) Schematic of a silicon strip sensor module [8]. While the module shown is for use in the barrel detector, the end-cap modules share the same basic structure and components. (b) Schematic of layers within a module loaded onto a petal. An adhesive with a low Young’s modulus, SE4445, is used to load the module to the petal; within the module, an adhesive with a high Young’s modulus, Eccobond F112, is used to attach hybrids and powerboards to the silicon sensor.

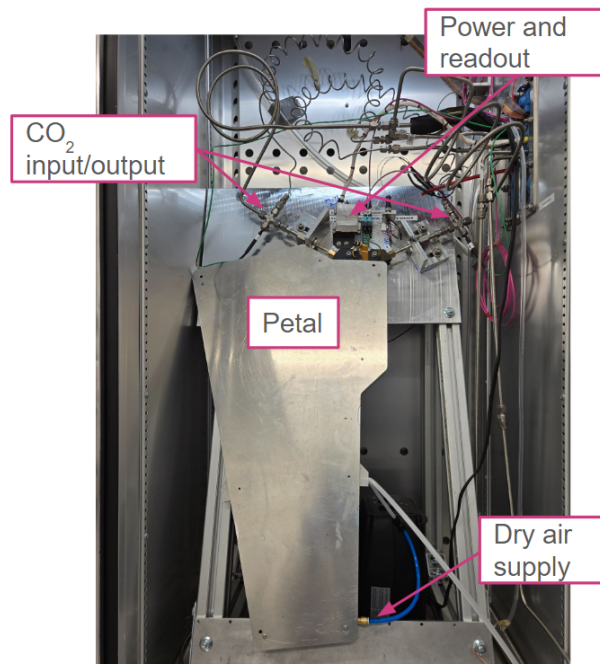
To verify that a petal meets its design requirements, extensive electrical tests are conducted during the QC process. The testing setup at each of the four ITk petal loading sites consists of a light-tight, thermally-isolated enclosure to hold the petal. Both the enclosure and the petal case are flushed with dry air to keep the relative humidity low,  $< 10\%$ , to prevent early breakdown of sensors [29]. Three of the four loading sites connect the petal to an active dual-phase  $\text{CO}_2$  cooling plant, the MARTA system [30], which allows for testing at temperatures ranging from  $+20$  to  $-35^\circ\text{C}$ . The fourth institute uses an active mono-phase ethanol cooling plant connected to the petal which allows for testing at temperatures ranging from  $+20$  to  $-75^\circ\text{C}$ . Both cooling systems allow for testing at temperatures at which the ITk is expected to operate, and the former is reflective of what will be used during operation,  $+20$  to  $-35^\circ\text{C}$  [31]. Figure 4 shows a picture of a petal connected to a liquid  $\text{CO}_2$  system, set up inside an enclosure.

**Figure 4:** Labelled picture of a petal in the enclosure for electrical testing [15].

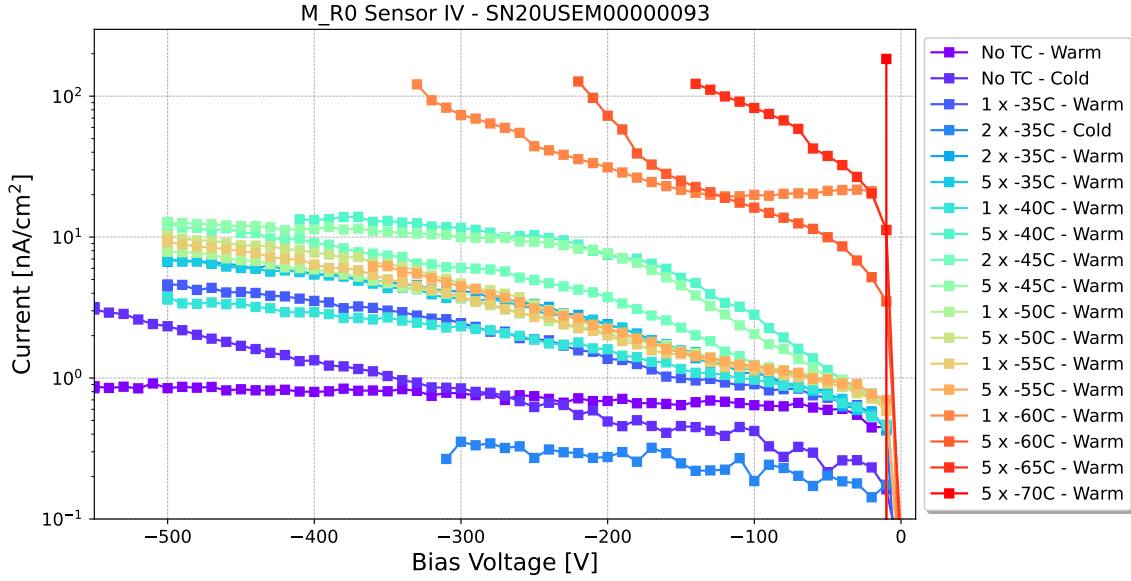
A rapid, exponential increase in sensor leakage current — known as early breakdown — could be indicative of sensor damage, damage from electrostatic discharge, contamination, or cracks. It is therefore considered one of the indicators of a sensor crack, but not conclusive proof. Figure 5 shows examples of IV scans. Scans ending at −500 V or −550 V correspond to normal IV scans. Scans ending before −500 V and below 100  $\text{nA}/\text{cm}^2$  were terminated due to the compliance limit set by the AMAC. Scans reaching 100  $\text{nA}/\text{cm}^2$  were terminated due to the compliance limit set by the HV power supply.

**Figure 5:** IV scans for an R0 module on a petal (“VAN3”); results are shown for various scans. In the legend, “ $N \times YC$ ” indicates a scan after  $N$  thermal cycles at a temperature of  $Y$  °C. “Warm” and “Cold” indicate scans performed at +20 and –35 °C, respectively.

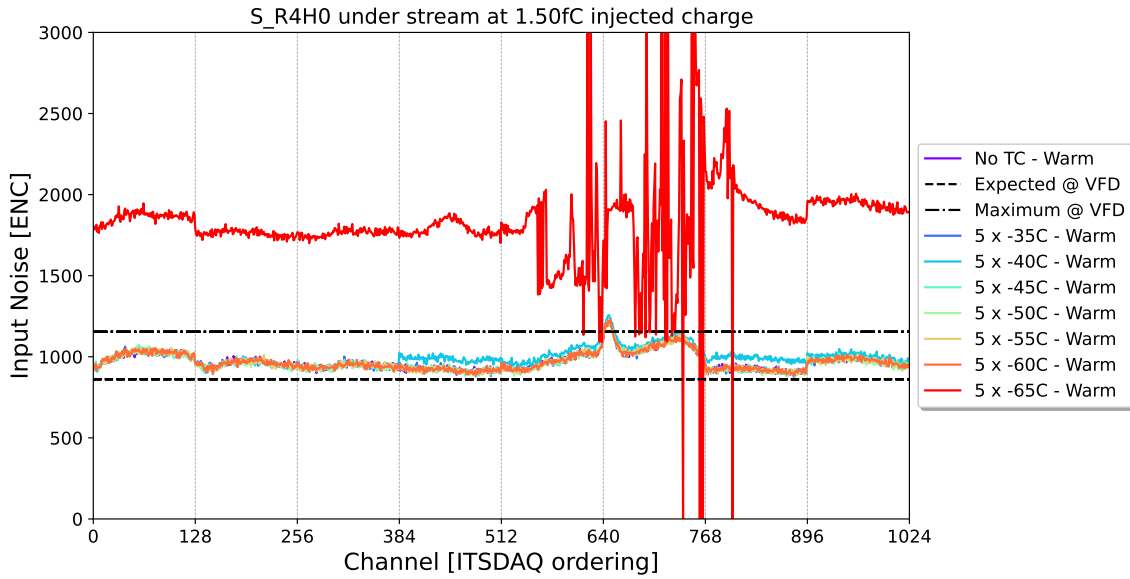
**Figure 6:** Typical noise signature from a crack on an R4 module on a petal (“VAN3”). Results are shown for every fifth thermal cycle and were each obtained at +20 °C (“Warm”). Also shown are the expected and maximum noise margins at full depletion voltage.

Next, the noise results of the suspect module are investigated, with cracks characterized by a cluster of channels of unusually low or high noise. Figure 6 shows DAQ scans for the under stream of an R4 module tested over many thermal cycles. Scans performed before the  $-65$  °C thermal cycle show a module within specifications, but afterwards the irregular noise results indicate a crack. The overall noise level increase for the  $-65$  °C scan is the result of a smaller bias voltage due to early breakdown after this cycle. The behaviour of the noise for a cracked module depends on the module geometry and location of the crack. Under stream cracks on sensors with four rows of strips (i.e., R0, R1, and R3 sensors) tend to break the bias resistor off resulting in higher noise, while under stream cracks on sensors with two rows of strips (R2, R4, and R5 sensors) tend to break after the bias resistor resulting in shorter strip lengths and thus lower noise. An example of low and high noise on R2 and R1 modules from the VAN3 petal is shown in figure 7.

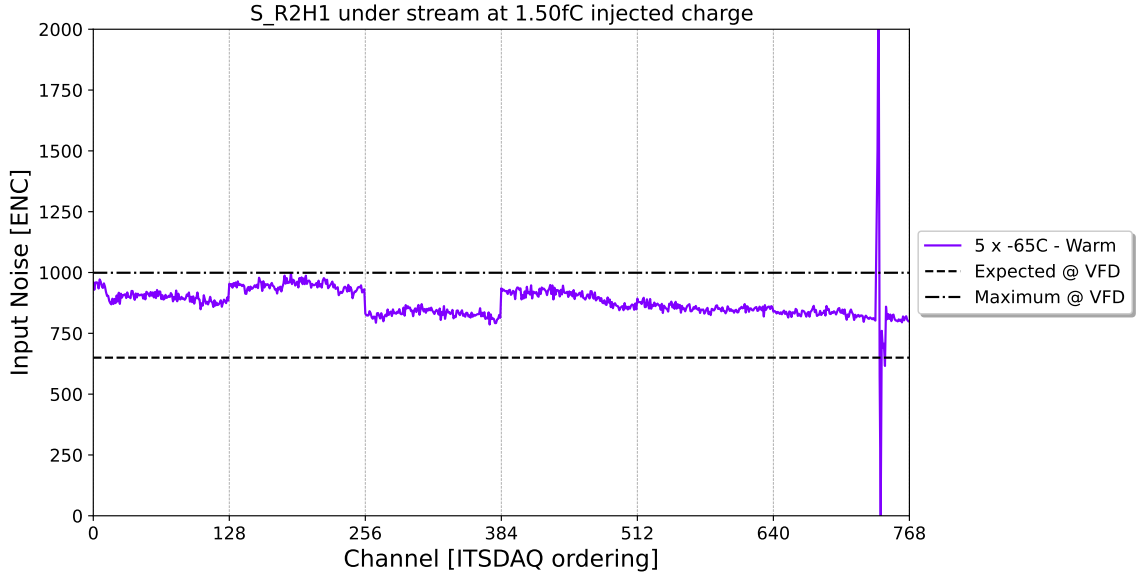
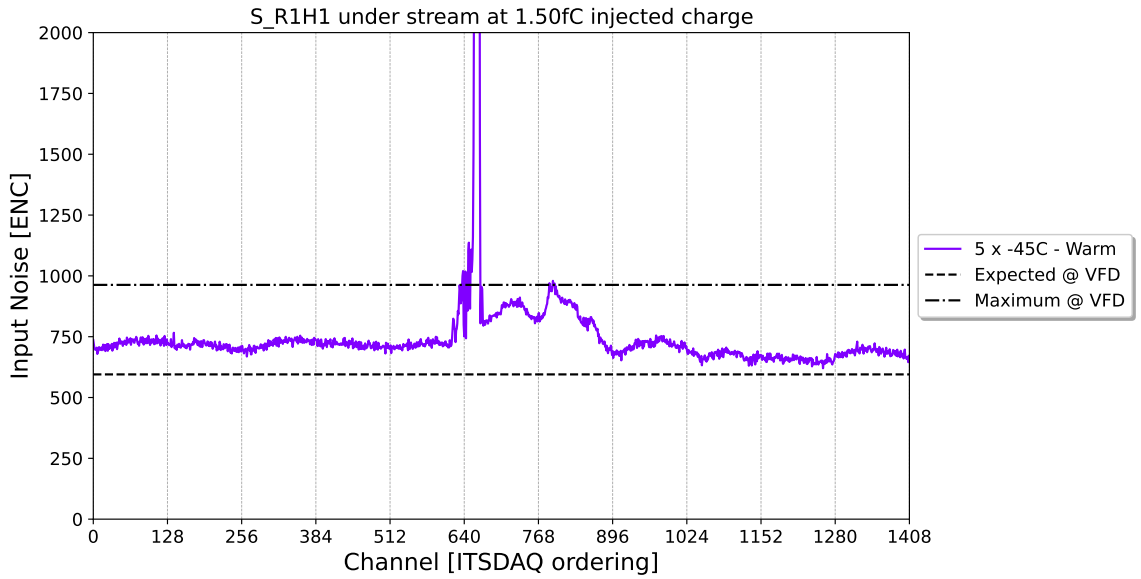
**Figure 7:** (a) R2H1 DAQ scan on a petal (“VAN3”) showing a crack signature around channel 730, characterized by low noise as compared to the neighbouring channels. (b) R1H1 DAQ scan on a petal (“VAN3”) showing a crack signature around channel 640, characterized by higher noise compared to the neighbouring channels.

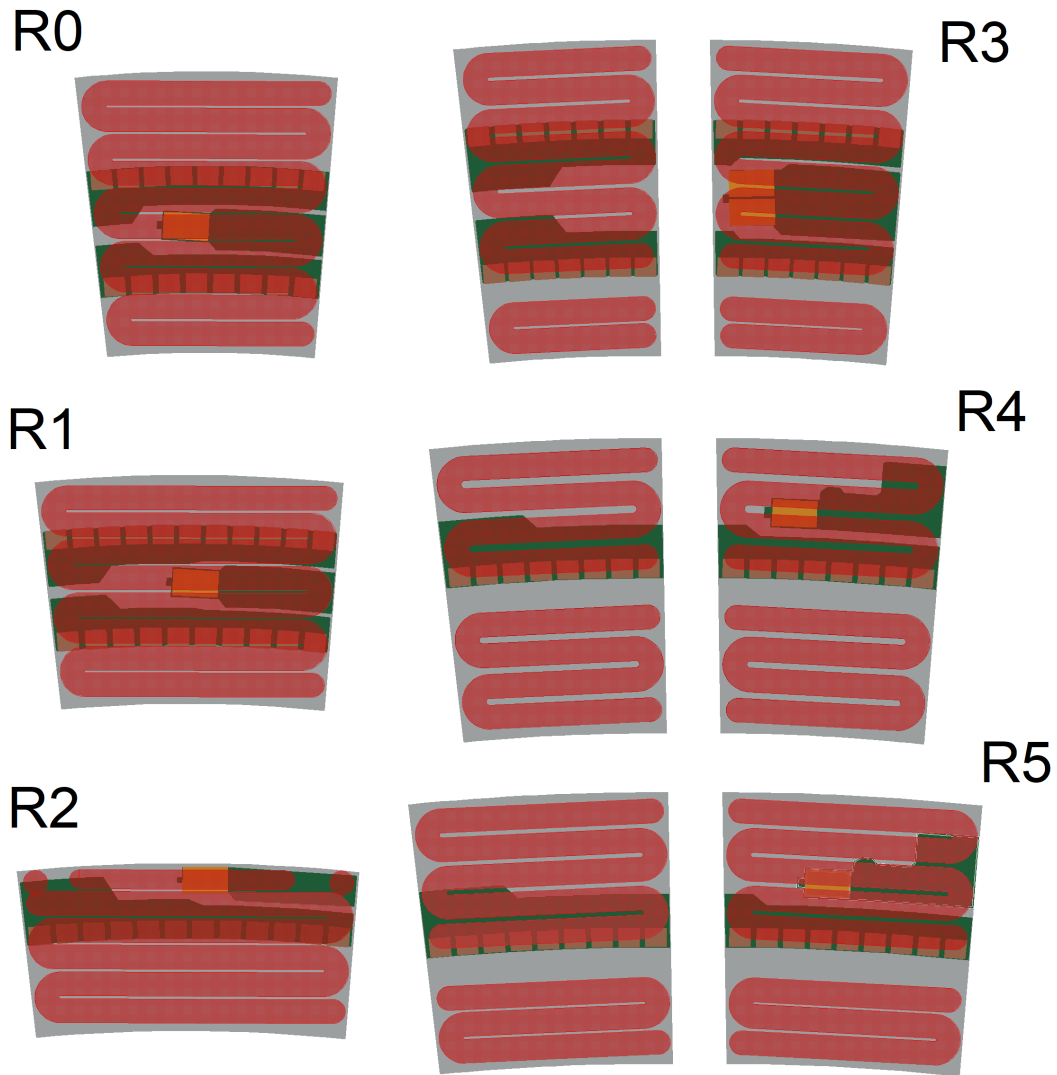
The initial petals built using the default adhesive, SE4445, in the default snake-like pattern (i.e., with no cracking mitigation strategies applied) are referred to as the default petals; these include the VAN2, IFIC2, and DESY1 petals. They were loaded with modules from the first iteration of pre-production and therefore used different PCB-to-sensor adhesives and were thermal cycled to different temperatures as part of module QC. They were loaded using SE4445 in a snake-like pattern as shown in figure 8. This default loading pattern was developed to maximize coverage under each module.

**Figure 8:** SE4445 loading adhesive in a snake-like pattern as seen for each type of module. The patterns are shown in red and the PCBs are shown in green. The different module types are not necessarily to scale.

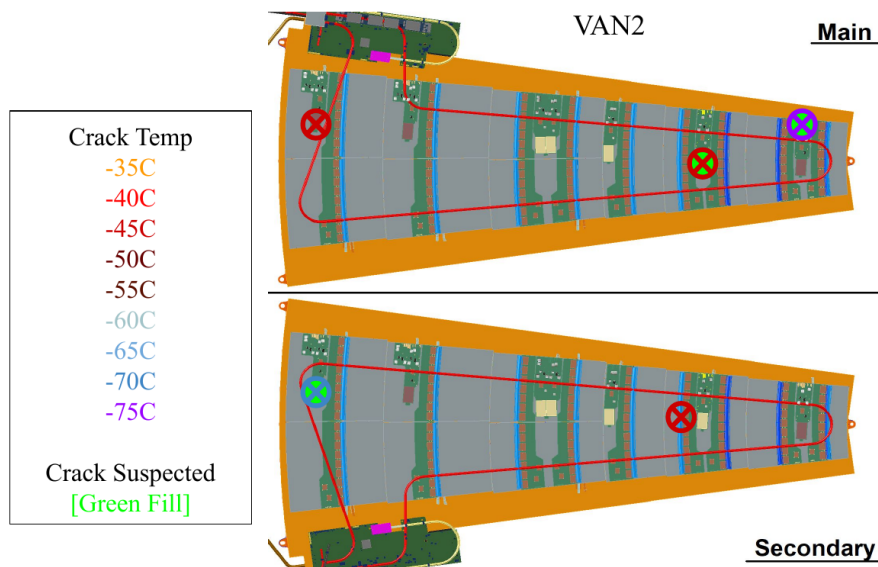
The VAN2 petal was initially subjected to passive thermal cycling down to  $-45^{\circ}\text{C}$ , after which it was transferred to a setup capable of active cycling to much colder temperatures, once the first cracks were identified. The petal was then actively thermally cycled to  $-75^{\circ}\text{C}$ . An overview of the suspected and visually confirmed crack locations is presented in figure 9.

The S\_R1 crack was located between two ABCs on the R1H1 hybrid. The M\_R5M0 crack was confirmed visually by removing the hybrid and was found to originate at a small adhesive patch directly under the powerboard. The remaining cracks were not confirmed visually: their locations are inferred from their noise signatures and from the confirmed crack locations on future petals (section 3.2).

**Figure 9:** Suspected and confirmed crack locations on the VAN2 petal, after each crack signature was seen in the IV and/or DAQ scans.

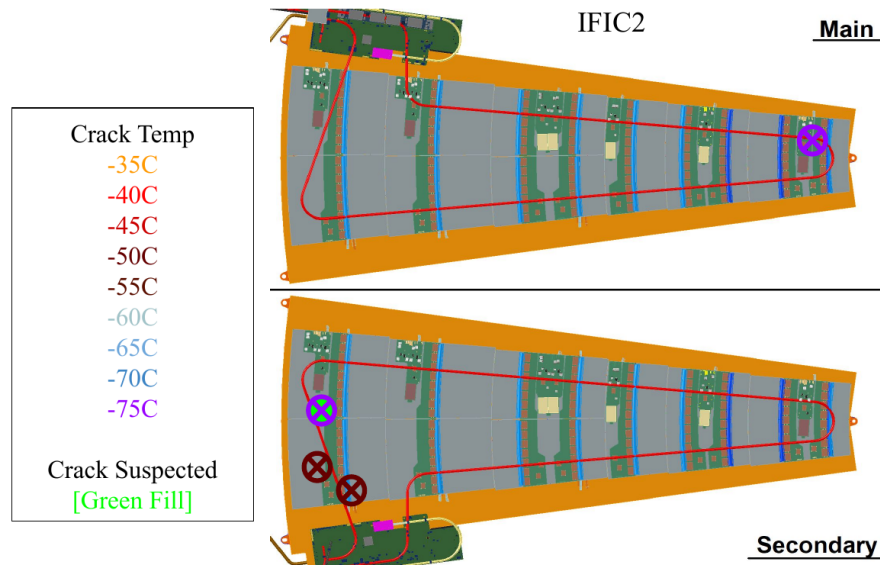
collected from these modules were excluded from further analysis. An overview of the suspected and visually confirmed crack locations is presented in figure 10.

**Figure 10:** Suspected and confirmed crack locations on the IFIC2 petal, after each crack signature was seen in the IV and/or DAQ scans. (†) The S\_R5M1 module cracked after first thermal cycle. (‡) The S\_R5M1 module cracked after second thermal cycle.

The S\_R5M1 cracks were visually confirmed after the first and second  $-50^{\circ}\text{C}$  cycles, extending nearly the width of the entire module. Two additional crack signatures were detected after the  $-75^{\circ}\text{C}$  cycle on the S\_R5M0 and M\_R0 modules. Figure 11 presents the noise for the S\_R5 module, arranged to match the module geometry, after the first cycle at each temperature. Similar cracks in the under streams of both sensors indicates similar internal stresses. Both cracks were visually confirmed to be above the hybrids. Figure 12 presents the two cracks seen on the S\_R5M1 module: the crack indicated in orange on the left-hand side, propagating under the wire bonds to ABCs, was identified after the first  $-50^{\circ}\text{C}$  cycle and corresponds to a typical hairline crack. The crack indicated in purple on the right-hand side was observed after the second  $-50^{\circ}\text{C}$  cycle; this crack is noteworthy as it splits the sensor into two physical pieces, which is highly unusual.

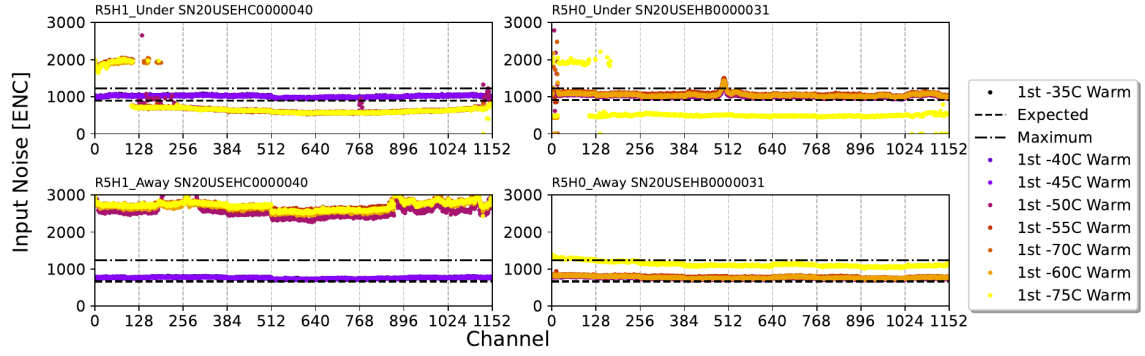
**Figure 11:** Noise results for the secondary side R5 module on the IFIC2 petal after the first cycle at each temperature. Under stream cracks across both sensors show lower noise than expected.

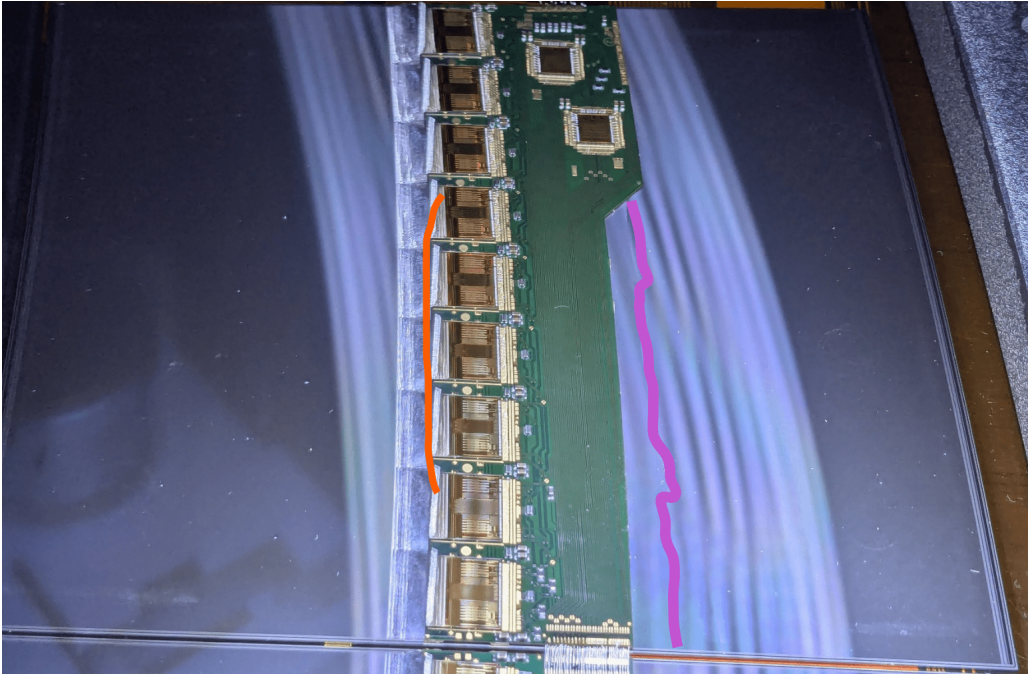
**Figure 12:** Visually confirmed crack locations on secondary side R5M1 module on the IFIC2 petal after the  $-50^{\circ}\text{C}$  cycles. The crack indicated in orange is a typical hairline crack, while crack indicated in purple fully separates the sensor into two pieces.

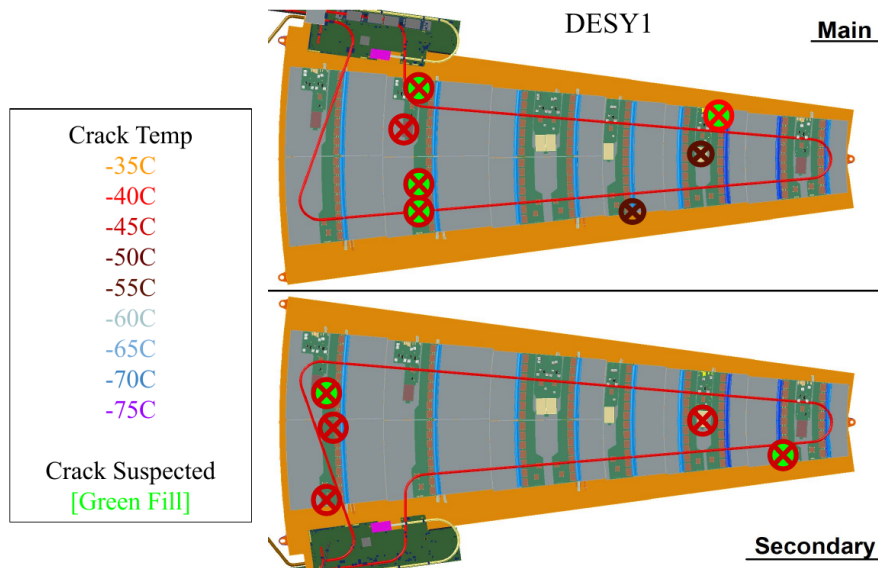
The DESY1 petal was actively thermal cycled and tested down to  $-55^{\circ}\text{C}$ . An overview of the visually confirmed and suspected crack locations on DESY1 are presented in figure 13. For

the M\_R4 and S\_R5 modules, multiple crack signatures were observed. One of these was visually confirmed on the S\_R5 module, located along the edge of the module and crossing the HV connection to the petal core.

The S\_R1 and M\_R4 cracks were both visually confirmed near the DC-DC converter. The M\_R2 crack was visually identified beneath the leftmost ABC, while the second M\_R1 crack was similarly seen propagating from beneath the DC-DC converter.

**Figure 13:** Suspected and confirmed crack locations on the DESY1 petal, after crack signature is seen in DAQ and/or IV scan. (†) The M\_R4M0 module had two crack signatures of which the one under the DC-DC converter was visually confirmed. (‡) The S\_R5M1 module had two crack signatures of which both were visually confirmed.

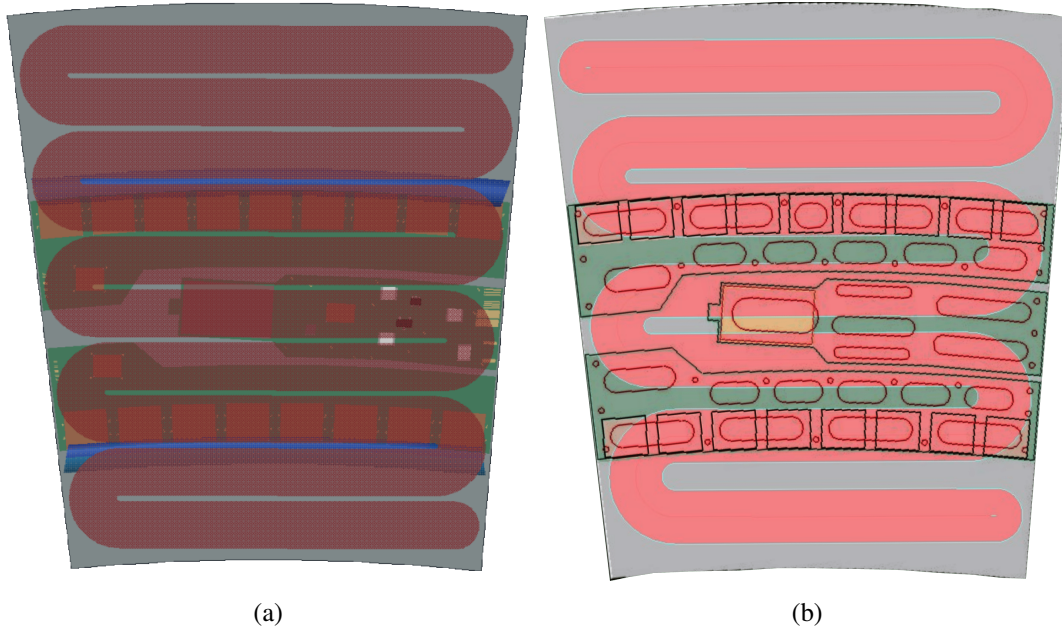
The new loading patterns developed for this petal based on these recommendations are seen as additionally optimized to provide support to the DC-DC converter and the ASICs. Figure 14 shows a comparison of the loading patterns used in the SE4445 and HYSOL default petals for an R0 module.

**Figure 14:** (a) Default pattern for an R0 module loaded with SE4445 in a snake-like pattern. (b) Default pattern for an R0 module loaded with HYSOL in a snake-like pattern overlaid with the hybrids, powerboard, and PCB-to-sensor adhesive pattern; the PCB-to-sensor adhesive pattern in (a) is the same as that shown in (b). HYSOL supports the PCB edges and gaps. The PCB-to-sensor adhesive pattern provides support to ASICs and DC-DC converter where small “glue-dots” are used to bridge the areas between adhesive patches.

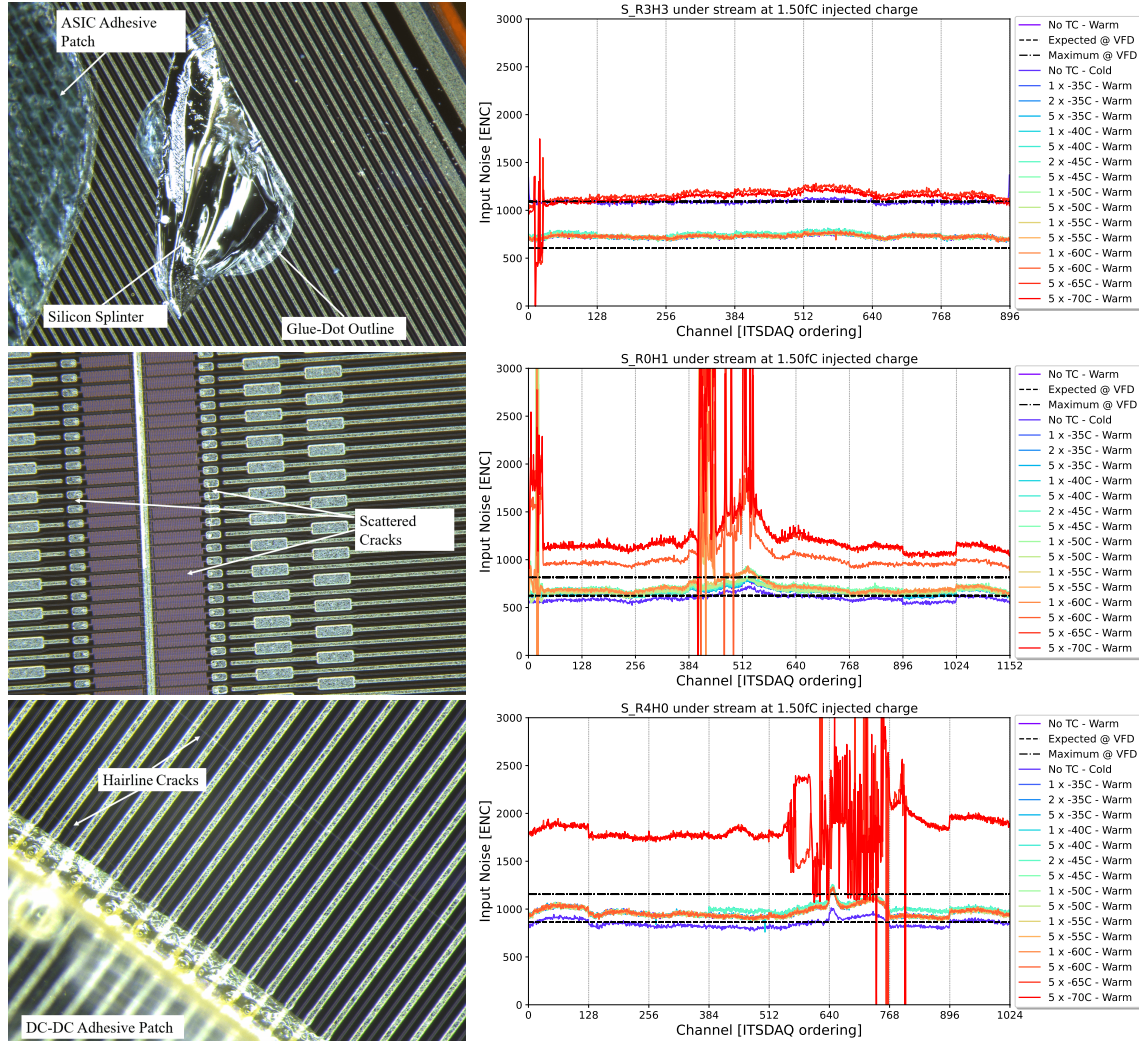
inspection of suspected regions under the PCBs yielded three categories of cracks. Figure 15 shows an image of the different types of crack found along with the noise signatures. An overview of the suspected and confirmed crack locations are shown in figure 16. These include twenty confirmed cracks and three additional suspected cracks that were not visually confirmed due to excessive adhesive coverage on the sensor surface.

The first category of cracks was where silicon splinters detached from the sensors together with the PCBs. These types of cracks were always found near glue-dots, small deposits of adhesive in the PCB-to-sensor pattern that are used to bridge the areas between adhesive patches. Specifically, ten cracks were found near glue-dots at the edges of the modules that had localized noise signatures which did not grow with successive thermal cycling. These types of cracks have minimal or absent HYSOL support underneath. These splinters suggested that the glue-dots without HYSOL support create a high stress location that cracks but is not allowed to propagate due to the glue-dot outline. The thickness of the silicon splinters (including the glue) also varied between cracks, ranging from 70–400  $\mu\text{m}$ , indicating that this type of cracking is not uniform.

The second category of cracks discovered are multiple short and scattered cracks across the bias resistors under the hybrids or powerboards, depending on the module. These types of cracks had noise signatures that range across multiple ABCs and grow with successive thermal cycling. These cracks occur in the gaps between the hybrids and powerboards on the edge of the HYSOL pattern. It is believed that minimal HYSOL support underneath creates multiple high stress locations that

The final category of cracks discovered were single long cracks spanning an area of two to three ABCs. Specifically, six cracks originated from and propagated along the nearby hybrid-to-sensor adhesive. These cracks occurred under the DC-DC converter and were on the edge of the HYSOL support underneath the sensor. The noise signature for these cracks also propagated across multiple ABCs.

**Figure 15:** Three categories of cracks discovered from the VAN3 petal. Each example is from the secondary side. (Top) Removed silicon splinter at an edge glue-dot on the R3M1 module. This type of crack has a localized noise shape which does not grow with colder thermal cycles. (Middle) Multiple short cracks across bias resistors on the R0 module. This type of crack has high and low noise channels spanning one or two ABCs. (Bottom) Single long crack on the R3M1 module spanning three ABCs. This type of crack is often seen near the adhesive outline under the DC-DC converter.

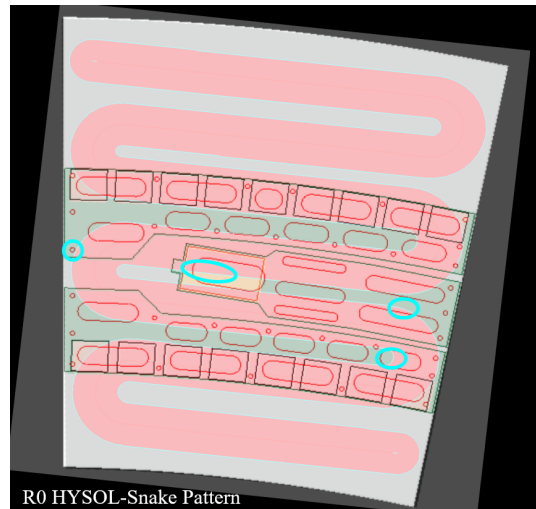
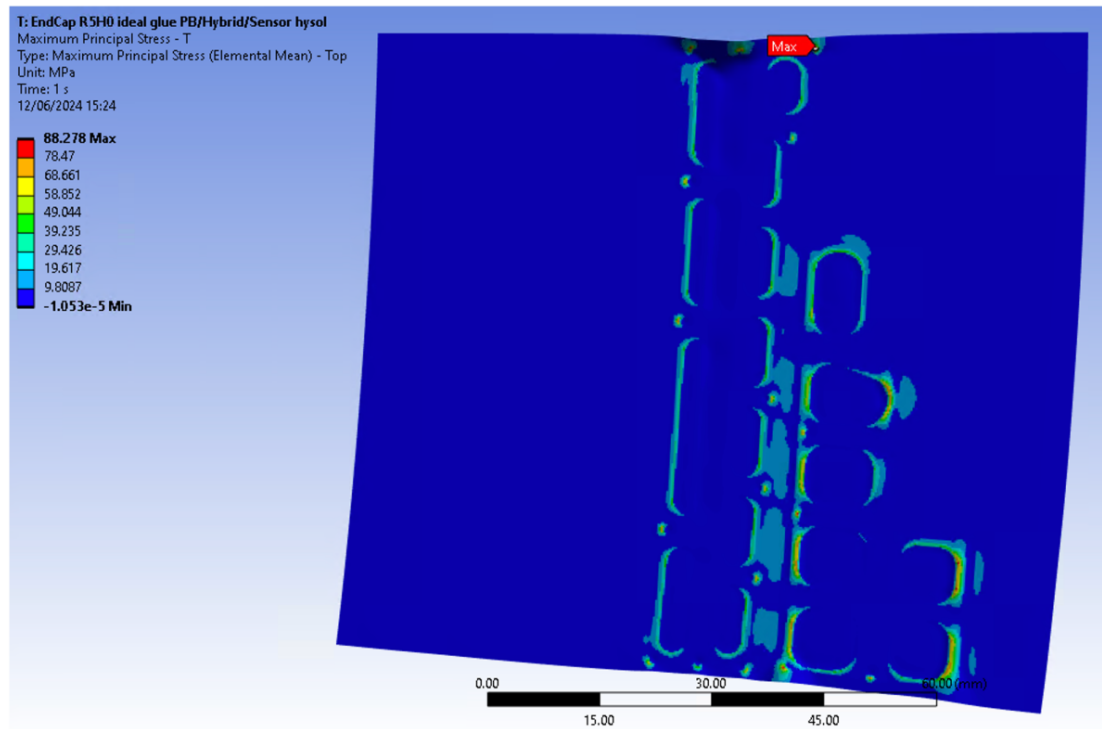
The HYSOL mitigation strategy was based on the premise that a harder adhesive would reduce the internal stress; however, in the VAN3 petal, a larger number of cracks (as compared to SE4445 default petals) were discovered and included a previously unobserved type of crack: silicon splinters. The combined result of the loading and PCB-to-sensor adhesive patterns led to regions of gaps with little-to-no HYSOL support and regions along the module edges with glue-dots and little-to-no HYSOL support. The cracks found on the VAN3 petal largely coincided with these regions and occurred mostly in different regions from the SE4445 petals, underneath PCBs and primarily along their short edges. After the VAN3 petal had finished thermal cycling, simulations of individual end-cap module geometries were implemented to confirm the suspected connection between the glue-dots in the PCB-to-sensor pattern and concentrated stress on the sensor. The simulation confirmed these adhesive areas to be those with the highest stress, as shown in figure 17.

**Figure 17:** (a) R0 loading pattern (solid red area) from figure 14 overlaid with regions where cracks were discovered (cyan ellipses). (b) Stress simulation of an R5 module using HYSOL in a snake-like loading pattern and a PCB-to-sensor pattern including glue-dots, showing local stress maxima where small glue-dots between PCB and sensor coincide with insufficient HYSOL support underneath.

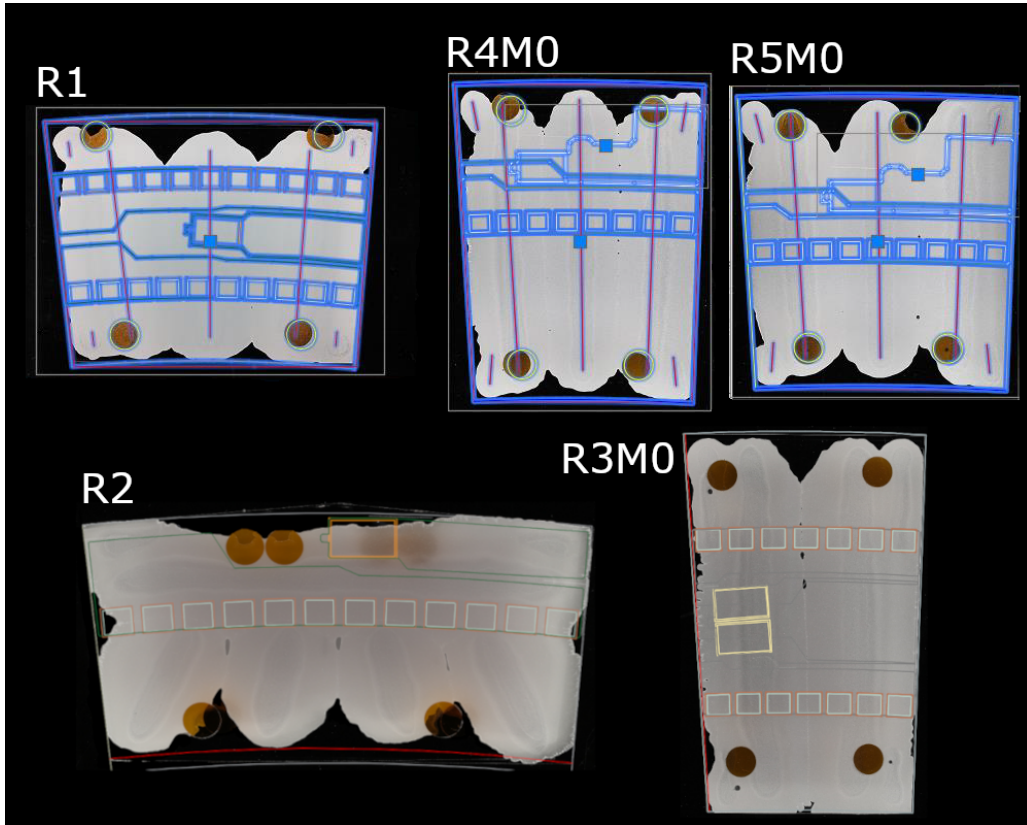
**Figure 18:** Examples of mechanical glass sensors loaded with HYSOL, shown in grey, in a full-coverage pattern, i.e. a pattern covering the entire area under each PCB. PCB patterns for each module type are additionally overlaid. The full-coverage patterns for R0, R3M1, R4M1, and R5M1 modules are similar to those shown above. The different module types are not necessarily to scale.

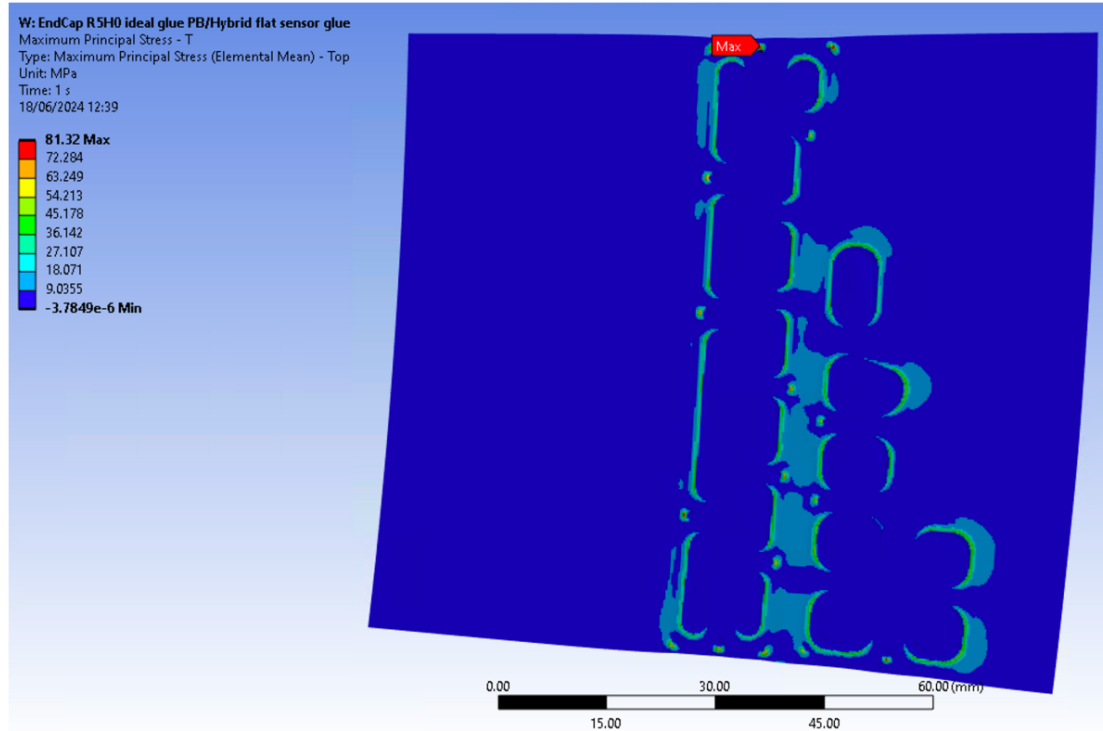
The goal of the VAN4 petal was to address the cracks present in the gaps between hybrids and powerboard of the snake-like loading pattern. Figure 19 shows the stress simulation for an R5 module with HYSOL in a full-coverage pattern and modules with glue-dots, as used on the VAN4 petal.

**Figure 19:** Stress simulation of an R5 module using HYSOL in a full-coverage loading pattern and a PCB-to-sensor pattern including glue-dots. The regions of highest stress occur at glue-dots and in particular along the edges, with the rest of the module showing lower stress compared to the snake-like pattern.

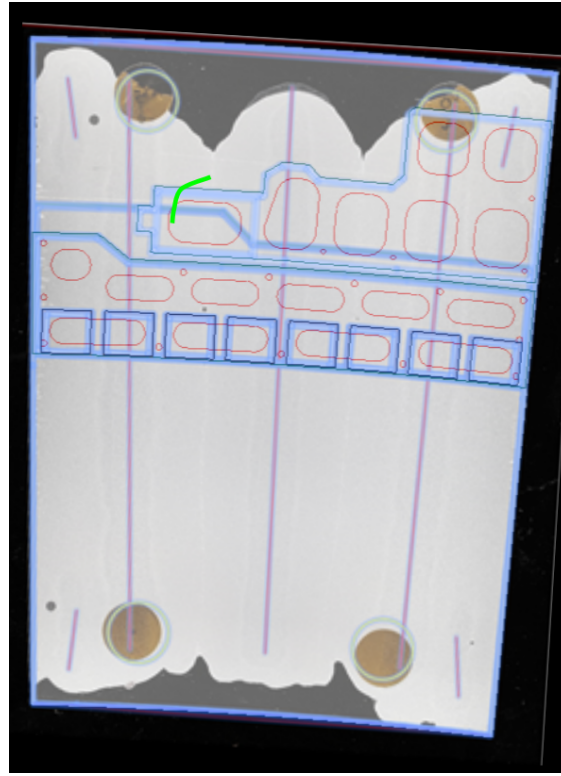
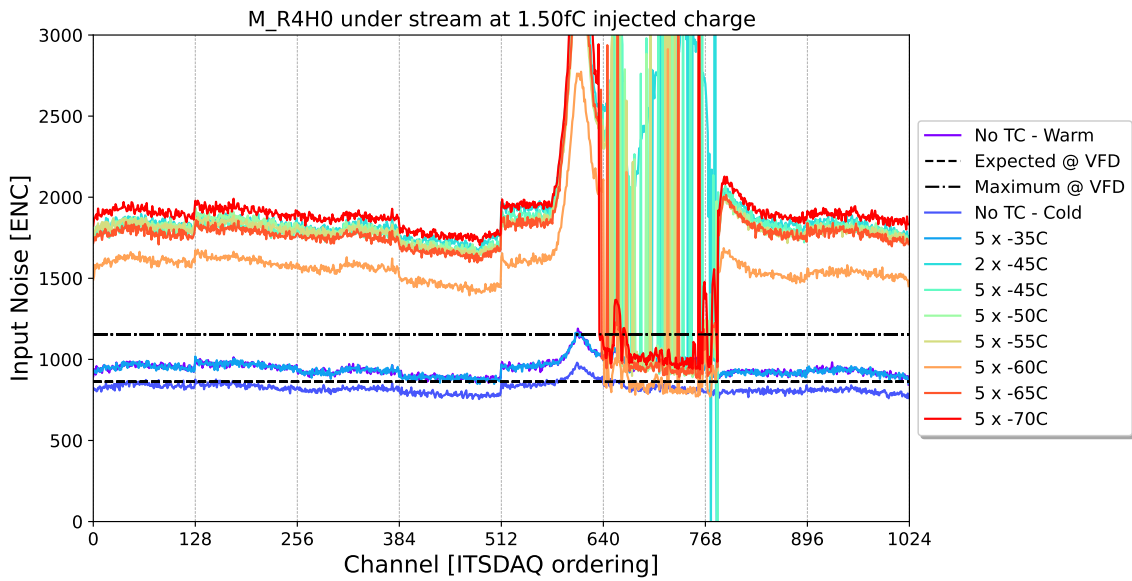
**Figure 21:** (a) Full-coverage HYSOL pattern, shown in light grey, for an R4M0 module overlaid with the PCBs, shown in blue, and showing the PCB-to-sensor adhesive pattern in red stencil. The visually confirmed crack is shown in light green. (b) Noise results for the M\_R4M0 over all temperature cycles. Noise results after the  $-55^{\circ}\text{C}$  cycle are much higher on average due to a smaller bias voltage. Readout order is reversed with respect to physical sensor geometry.

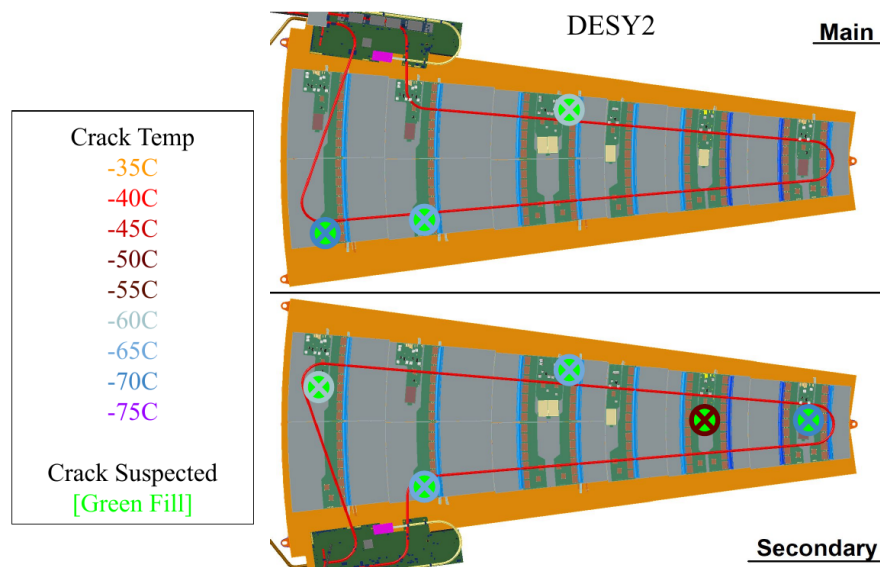
**Figure 23:** Suspected crack locations on the DESY2 petal, after each crack signature was seen in the IV and DAQ scans.

A total of eight crack signatures were seen, which are summarized in figure 23. None of the eight crack signatures were visually confirmed, but three were near the DC-DC converters and the remaining at the edges, locations consistent with previously discovered cracks.

The S\_R1 crack, which occurred during thermal cycling at  $-50^{\circ}\text{C}$ , was the first observation of a crack signature occurring in between the cold and warm cycle. The M\_R3M0 module showed similar behaviour to the S\_R1 module, with early breakdown occurring between the fourth cold cycle at  $-60^{\circ}\text{C}$  and the subsequent warm cycle. Similarly, the S\_R3M0 module exhibited a crack signature between the third and fourth cycles at  $-65^{\circ}\text{C}$ .

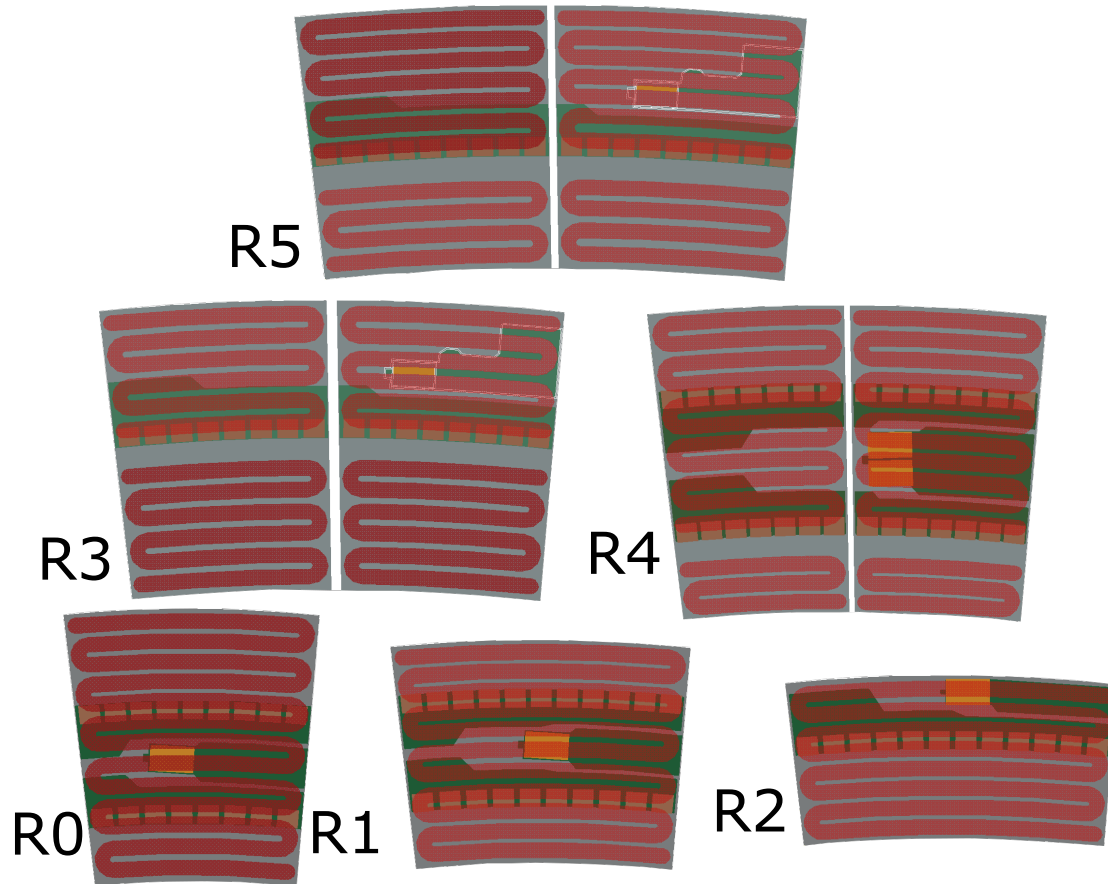
Two petals were constructed using the Improved Nominal assembly patterns for modules and module loading outlined in section 3.4.1. Figure 24 shows the improved loading pattern overlaid with the PCBs, highlighting the snake-like pattern and the high degree of coverage. In this paper, two petals loaded using the Improved Nominal design — VAN6 and VAN7 — are discussed.

**Figure 24:** Loading adhesive patterns for the Improved Nominal design, in red, and overlaid with the PCBs, in green. The different module types are not necessarily to scale.

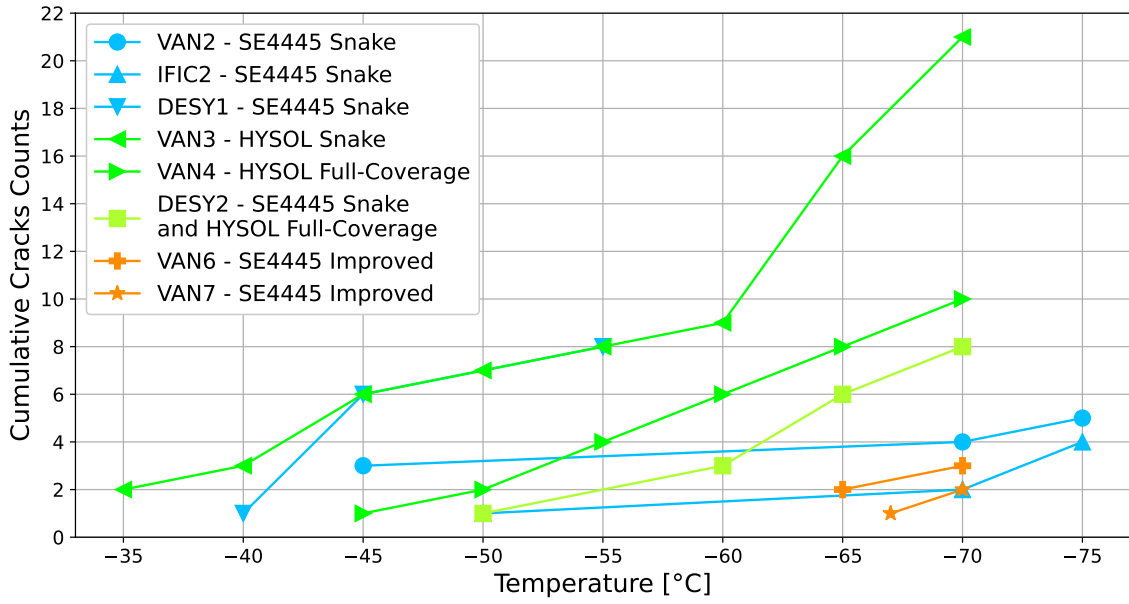
While cracks still formed on the Improved Nominal petals, the number of cracks and the temperature at which they first occurred was lower than for the previous petal designs. This confirmed that using SE4445 as the loading adhesive and removing the glue-dots from module adhesive pattern is the most promising mitigation strategy that does not change the module stackup to reduce stress. The temperatures at which cracks were observed in the Improved Nominal petals demonstrate that this mitigation provides increased headroom against the apparition of cracks compared to the default and the HYSOL mitigation strategies. Figure 27 shows a cumulative summary of the cracks observed across mitigation petals.

**Figure 27:** Summary of the number of (suspected plus observed) cracks across all mitigation petals. Comparing the onset of cracks in petals of the Improved Nominal design (orange) to that in petals without cracking mitigation (blue) or those utilizing HYSOL as a loading adhesive (green), there is approximately 10 °C of headroom provided by the Improved Nominal approach. Note that this plot does not include the additional results described in section 3.5.3.
