# Integrated Laser Scanning and Image-Based Topology Optimization Techniques for Detection and Quantification of Visible and Subsurface Structural Defects

## ABSTRACT

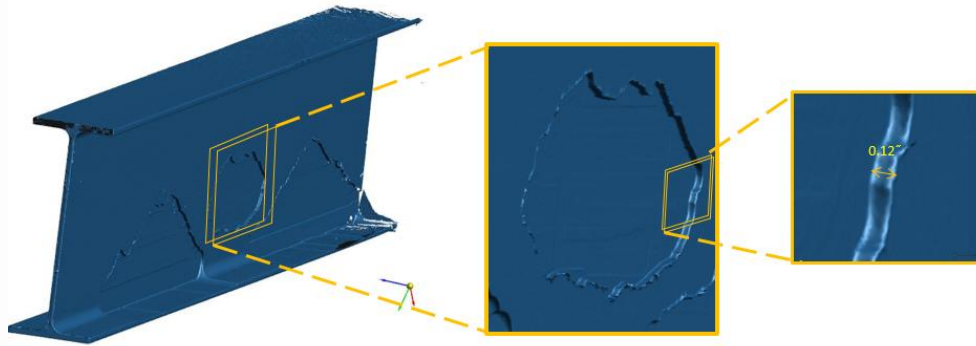
*Figure 1. Surface-scan data collection for the 4-ft steel beam containing randomly distributed defects on the rear surface.*

The first approach uses direct 3D geometric measurements obtained by high-resolution laser scanning to characterize surface defects and update the geometry of the corresponding numerical model (Figure 1).

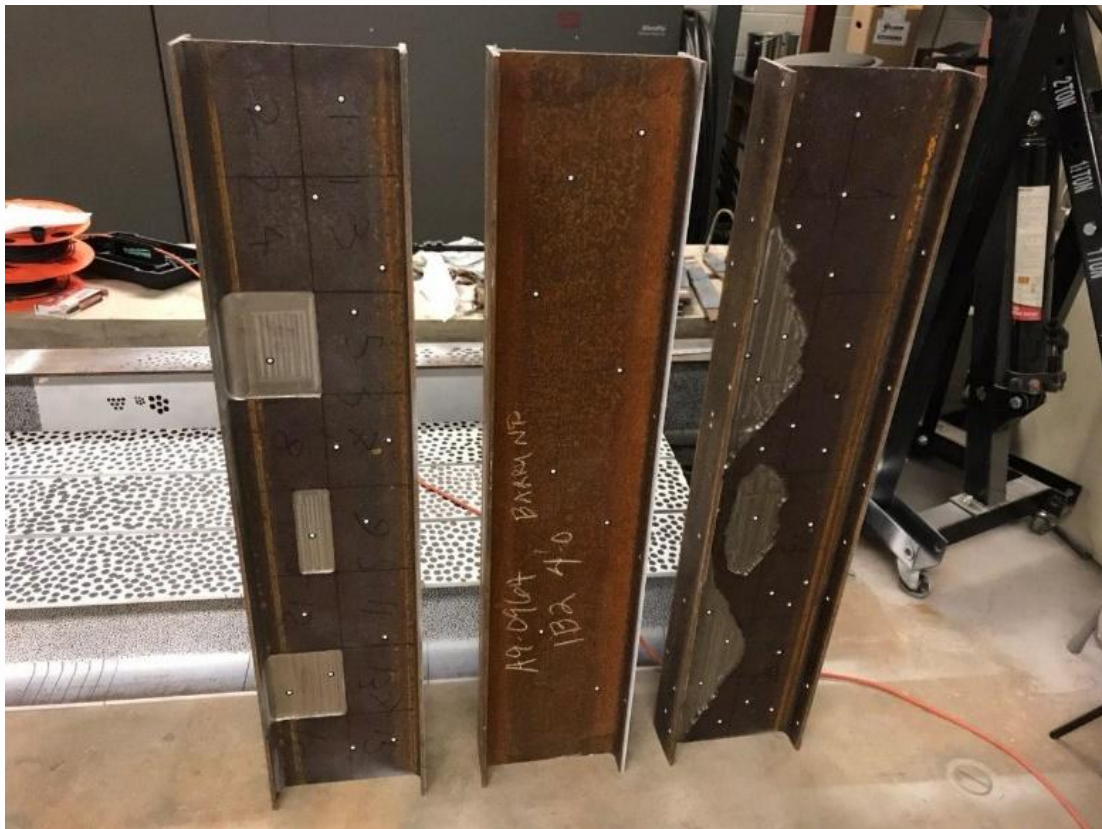
*Figure 2. Steel-beam specimens used in the experimental investigation.*

Depending on the damage mechanism, the measured geometry can be represented through localized element removal or reduction, introduction of geometric imperfections, or loss of connectivity. In the present study, steel beams were scanned to capture both nominal geometry and defect-induced surface variations (Figure 2). Following the procedure developed in prior work, the measured point-cloud data were compared with an as-built or reference point cloud to identify localized geometric deviations associated with damage. Computer-vision-based processing was then used to locate, isolate, and quantify the damaged regions. Rather than reconstructing the complete surface of the structural component, only point-cloud subsets associated with the detected defects were extracted and mapped to the existing solid model. The locally modified model was subsequently remeshed for finite element analysis. This localized updating strategy preserves the spatial resolution available from the point cloud in damaged regions while limiting unnecessary computational expense elsewhere in the model (Figure 3).

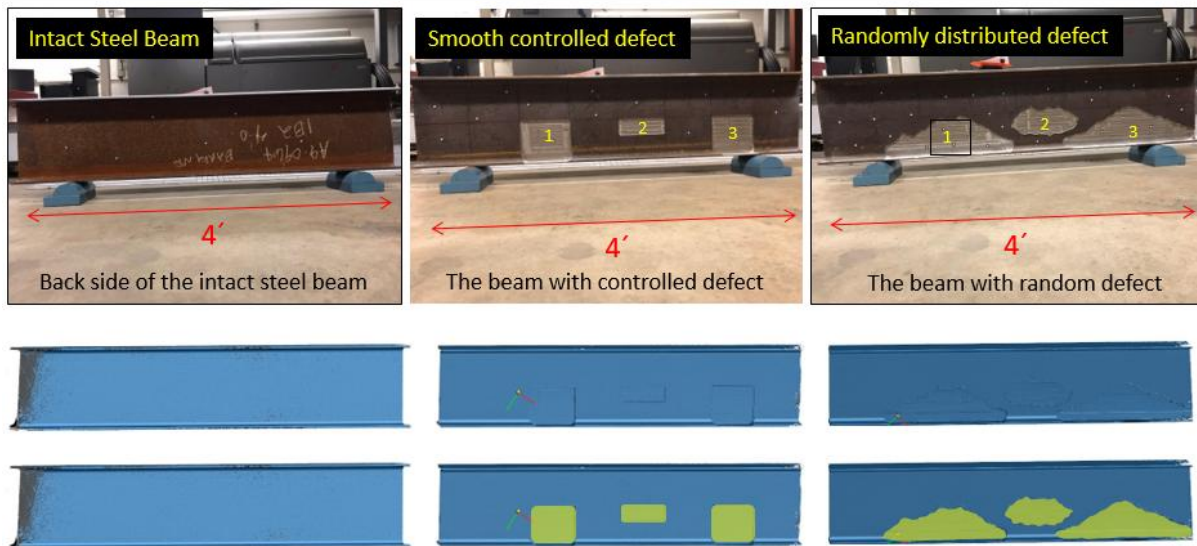
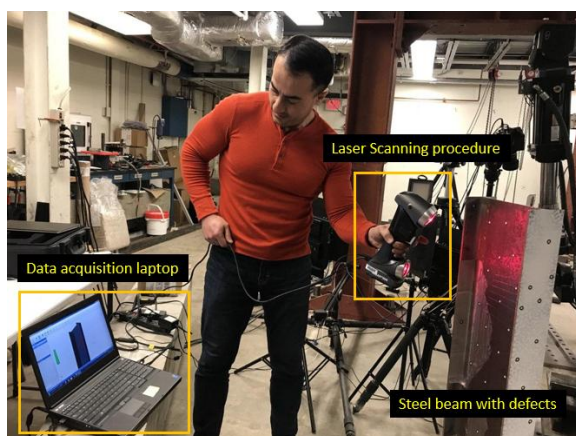
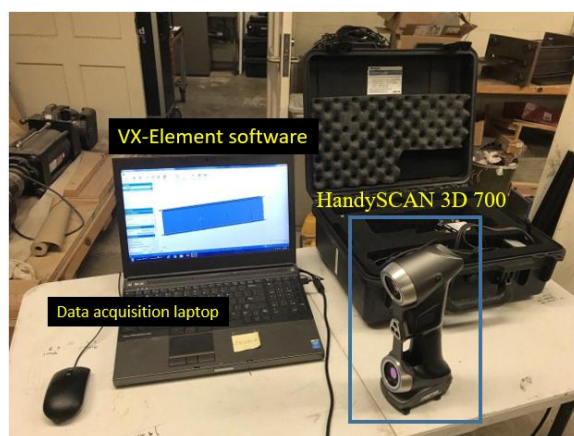
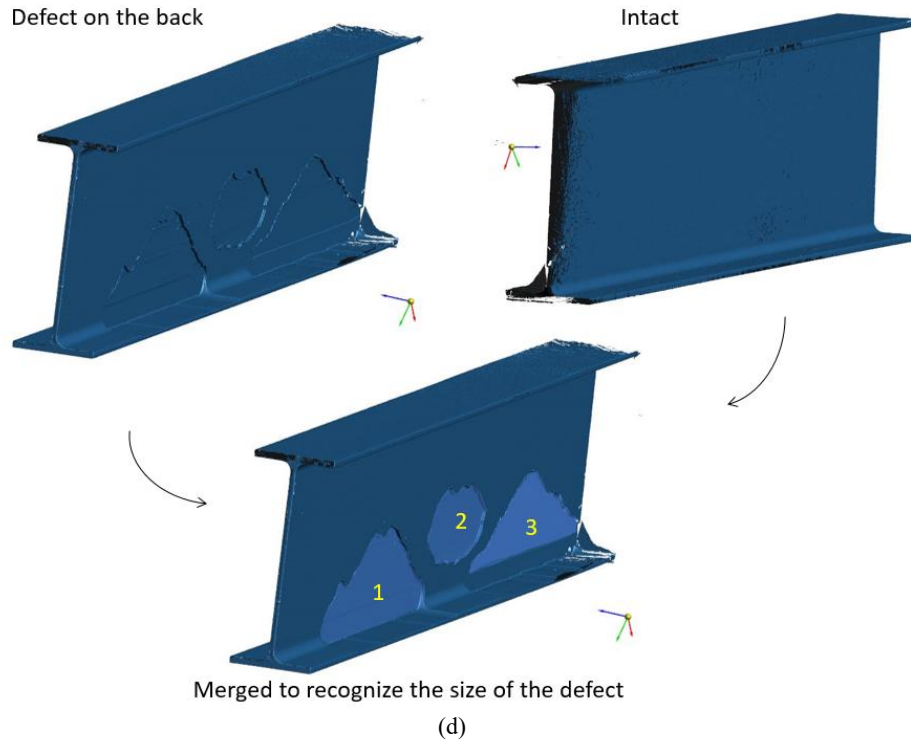
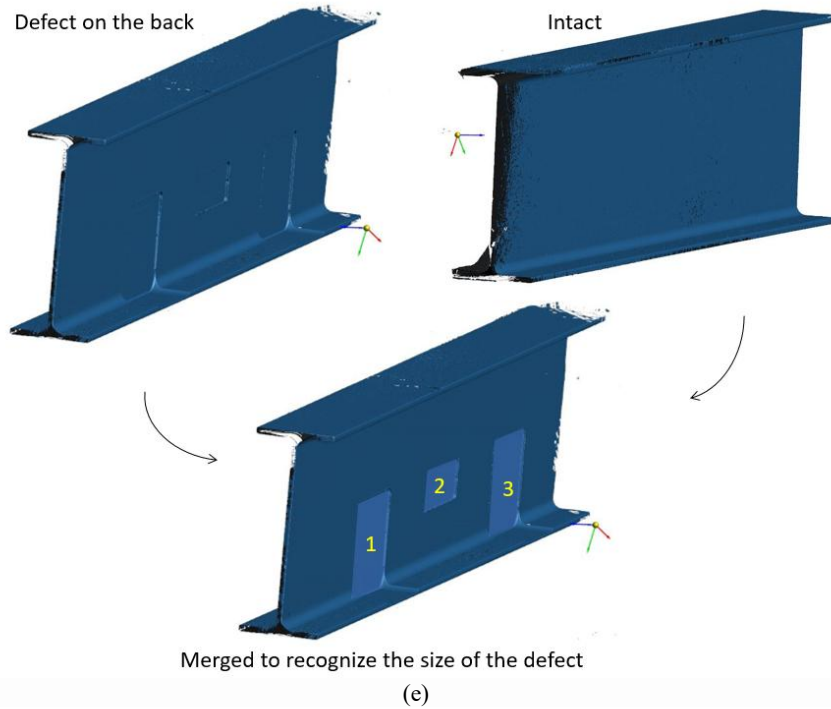
Figure 3. Laser-scanning equipment and experimental setup: (a) scanning procedure; (b) laser-scanning device; and steel-beam specimens comprising an intact beam, a beam with controlled smooth defects on the rear surface, and a beam with randomly distributed defects on the rear surface.

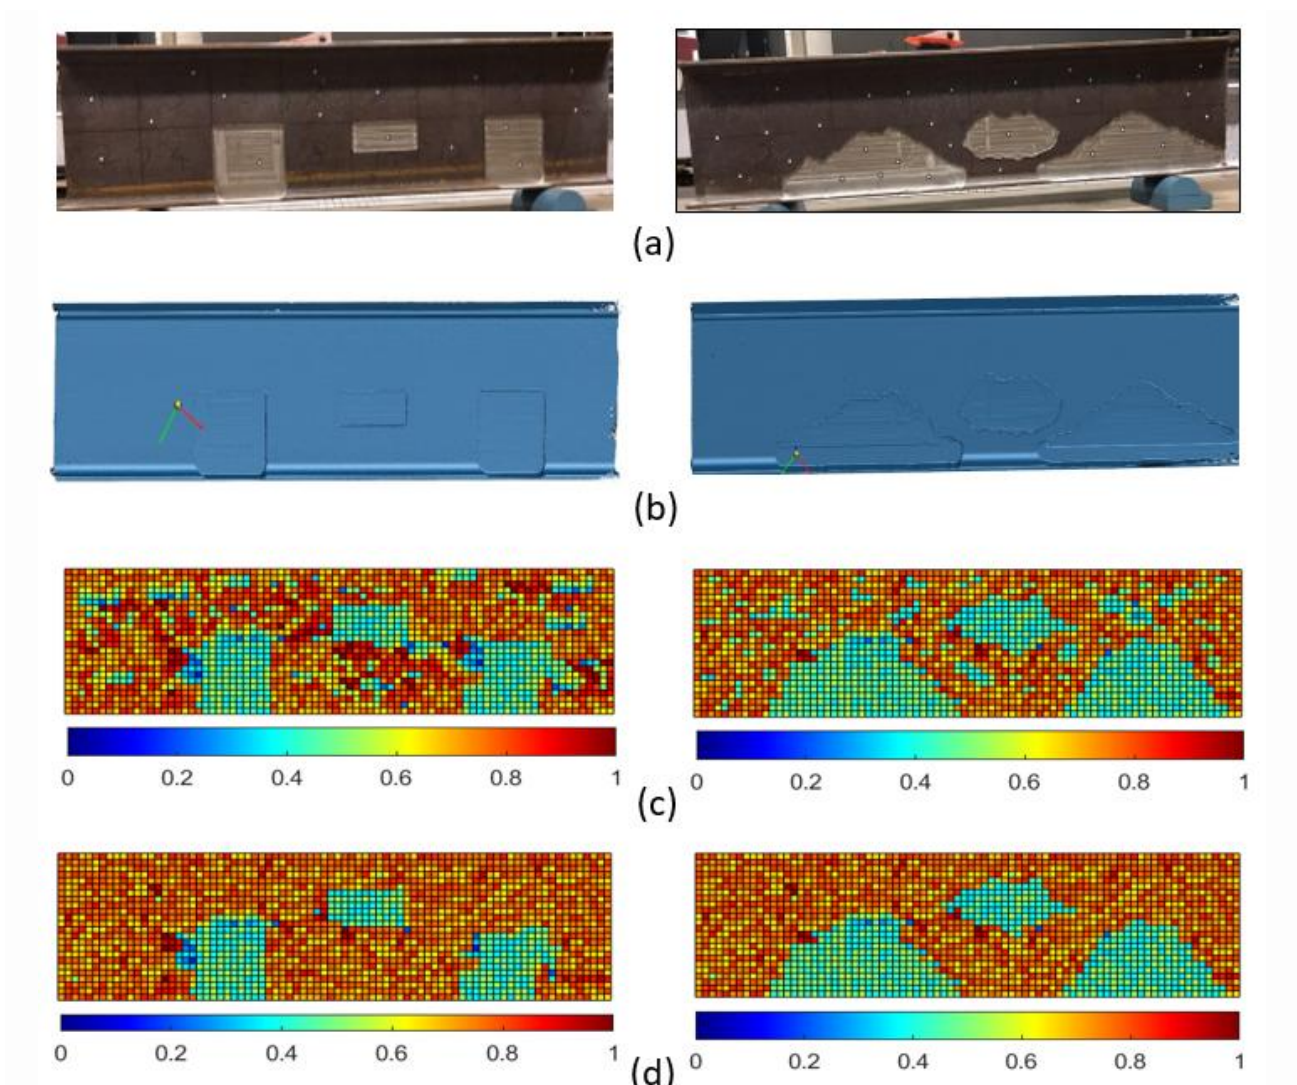
Figure 4. Comparison of laser-scanning-based defect detection and topology-optimization results: (a) 4-ft steel beam with smoothly distributed controlled defects on the rear surface; (b) 4-ft steel beam with randomly distributed defects on the rear surface; (c) topology-optimization result before post-processing; and (d) topology-optimization result after post-processing.

The second approach is based on the hypothesis that internal abnormalities can be inferred from their influence on measured surface deformation fields. Subsurface defects may be represented as localized anomalies in material-property distributions or as geometric discontinuities that alter the structural response. Accordingly, spatial perturbations in full-field displacement and strain measurements can provide indirect information regarding the location, shape, and severity of otherwise unobservable damage. The proposed framework combines full-field deformation measurements from 3D digital image correlation (3D-DIC) with analogous response fields predicted by a finite element model. These data are incorporated into an inverse structural-identification procedure formulated within a topology-optimization framework. During model updating, candidate finite elements in regions associated with potential damage are adjusted to reduce discrepancies between experimentally measured and numerically predicted response fields. The approach can therefore incorporate visible-damage information obtained from laser scanning while using static or dynamic 3D-DIC measurements to identify additional non-visible abnormalities. Structural steel specimens provide a nominally homogeneous material system for proof-of-concept validation and facilitate evaluation of the method under controlled defect configurations. The framework builds on the authors' prior work in full-field structural identification and subsurface damage detection [1–7] and extends those concepts toward combined surface and internal defect characterization (Figure 4).

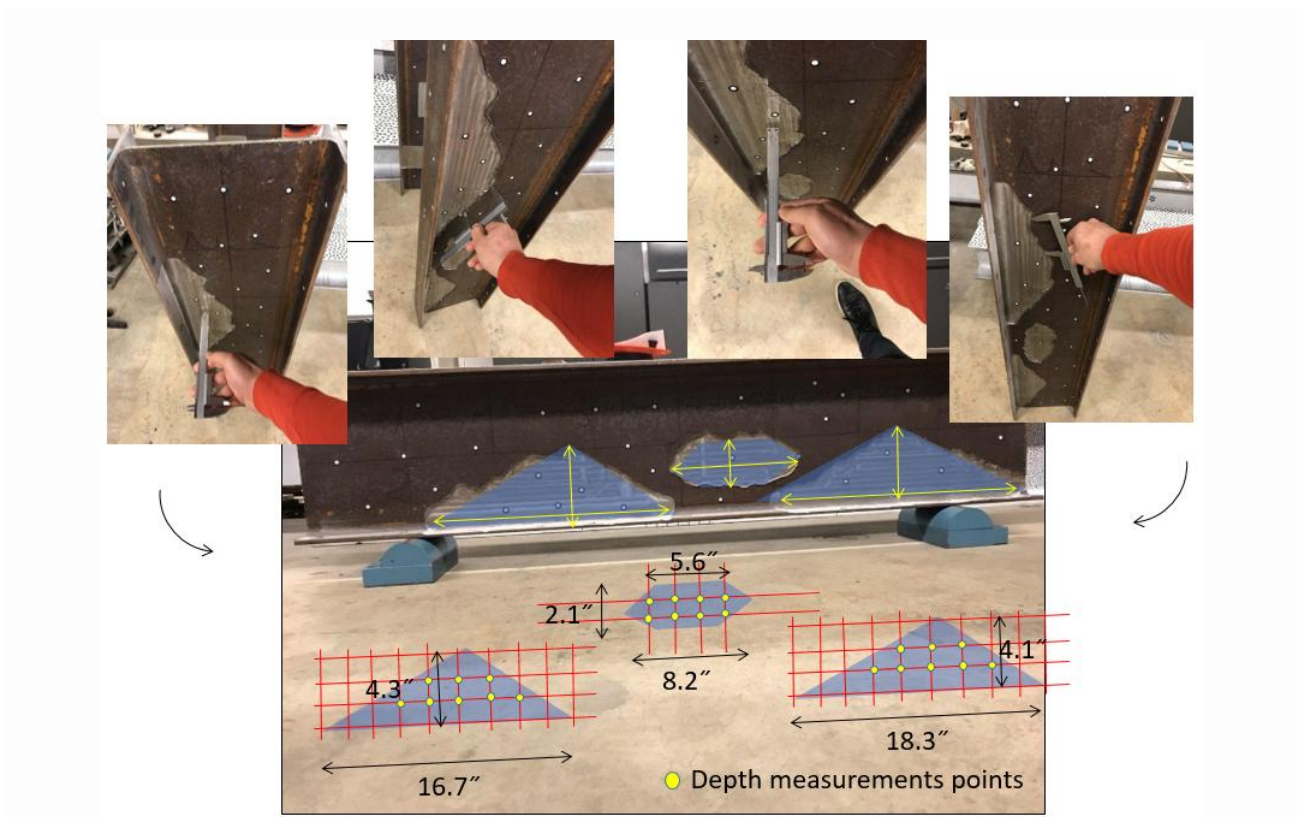
Figure 5. Visual measurement of defect depth, width, and length.

Overall, the experimental comparisons support the feasibility of integrating direct three-dimensional geometric measurements with full-field image-based structural identification. Laser scanning provides high-resolution information for visible surface damage, while 3D-DIC combined with topology optimization offers a pathway for identifying abnormalities through their influence on structural response. Agreement between these independent measurement principles can increase confidence in defect localization and quantification and provides a foundation for an integrated nondestructive evaluation framework applicable to geometrically complex or partially hidden structural damage (Figure 5).
