User Prompt

What defect is present in the image?

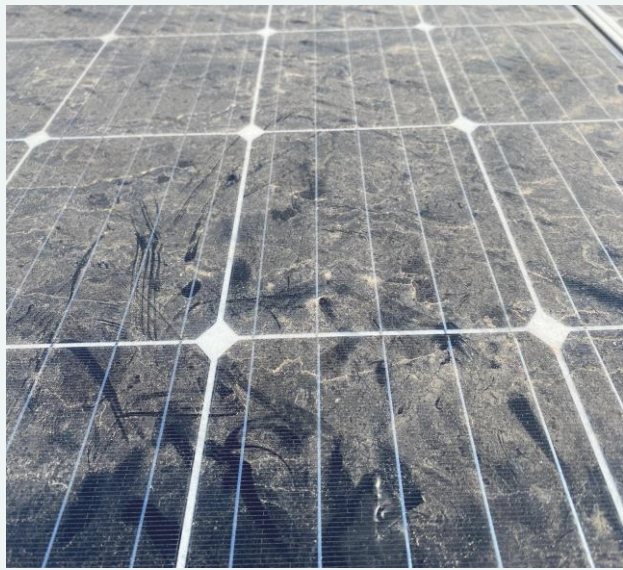
**Defect Type:** Clean Panel  
**Confidence:** 100%  
**Alternative Classification:**  
- Cannot be classified to others  
**Most Likely Cause:** No Defect/Normal Operation  
**Visual traits observed:** The panel surface exhibits diffuse streaks and spots of dust or dirt, creating a hazy pattern. However, no cracks, burns, black cores, or dislocations are present.  
**Recommendation:** No immediate action needed

The defect is heavy soiling and surface contamination on the solar panel glass, which reduces light transmission and efficiency.

**Defect Type:** Clean Panel  
**Defect Category Probabilities:**  
- **Clean Panel:** 80%  
- **Short Circuit:** 15%  
- **Black Core:** 5%  
**Most Likely Cause:** Panel is defect-free and functioning correctly.  
**Visual traits observed:** Completely black image, no visible defects or irregularities.  
**Recommendation:** No remediation needed. Panel appears to be in good condition.

**Defect Type:** Clean Panel  
**Defect Category Probabilities:**  
- **Clean Panel:** 80%  
- **Dirt Accumulation:** 15%  
- **Surface imperfection:** 5%  
**Most Likely Cause:** Environmental exposure resulting in surface accumulation.  
**Visual traits observed:** Presence of what seems to be dirt/debris across multiple cells.  
**Recommendation:** Regular cleaning of the panel surfaces is recommended.

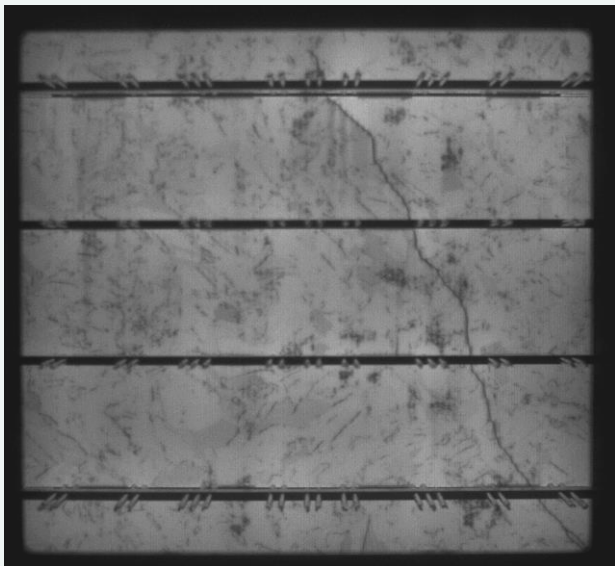
**Defect Type:** Crack  
**Confidence:** 80%  
**Alternative Classification:**  
- Black Core, Vertical Dislocation, Finger  
**Most Likely Cause:** Mechanical / Thermal Stress  
**Visual traits observed:** Diagonal crack line running continuously across multiple solar cells from upper region downward  
**Recommendation:** Replace the panel

The defect visible here is a cell crack (microcrack) — the dark, jagged line running across the cell indicates a fracture in the silicon.

**Defect Type:** Crack  
**Defect Category Probabilities:**  
- **Crack:** 95%  
- **Delamination:** 5%  
- **Contamination:** 5%  
**Most Likely Cause:** Mechanical stress during handling or installation, or thermal stress from temperature fluctuations.  
**Visual traits observed:** Thin, dark, linear features traversing multiple cells.  
**Recommendation:** Further inspection is recommended to assess the severity.

**Defect Type:** Crack  
**Defect Category Probabilities:**  
- **Crack:** 95%  
- **Microcrack:** 3%  
- **Snail Track Crack:** 2%  
**Most Likely Cause:** Mechanical stress during handling or thermal stress.  
**Visual traits observed:** A distinctive crack line spanning multiple cells.  
**Recommendation:** Replacement recommended to prevent further performance degradation and potential safety issues.

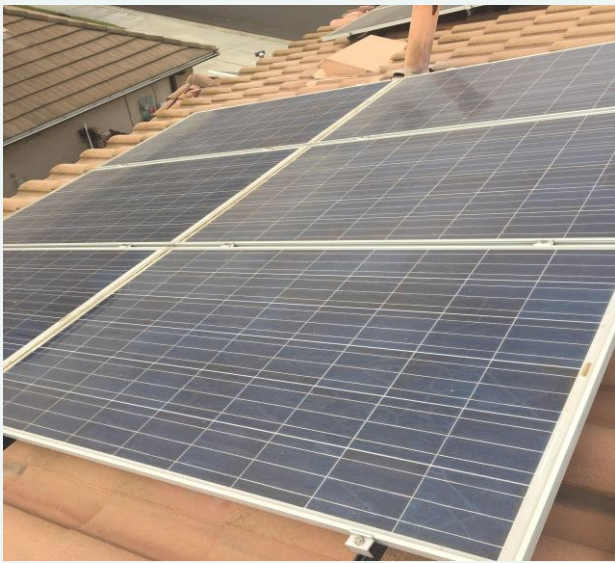
**Defect Type:** Clean Panel  
**Confidence:** 100%  
**Alternative Classification:**  
- Cannot be classified to others  
**Most Likely Cause:** No Defect/Normal Operation  
**Visual traits observed:** Multiple intact modules exhibit a consistent blue-black color with no visible defects  
**Recommendation:** No immediate action needed

A likely defect here is snail-trail/microcrack damage — faint whitish lines and discoloration across some cells indicate underlying cell micro-cracks, not shading.

**Defect Type:** Clean Panel  
**Defect Category Probabilities:**  
- **Clean Panel:** 95%  
- **Finger:** 3%  
- **Crack:** 2%  
**Most Likely Cause:** Proper manufacturing and installation, with no external factors causing damage.  
**Visual traits observed:** Uniform surface, no visible cracks, discoloration, or hotspots.  
**Recommendation:** No remediation needed. Continue regular maintenance and monitoring.

**Defect Type:** Clean Panel  
**Defect Category Probabilities:**  
- **Clean Panel:** 95%  
- **Minor dirt/dust:** 4%  
- **Surface imperfection:** 1%  
**Most Likely Cause:** Environmental factors such as dust, pollen, or bird droppings.  
**Visual traits observed:** Pristine surface, clearly defined cells and busbars, minimal visible debris.  
**Recommendation:** Regular cleaning of the panel surfaces is recommended.
