## Description:

There are 16 lesions in this panoramic radiograph. Because Prosthetic Restoration is classified as obvious findings, it is excluded from the proposal clustering process.

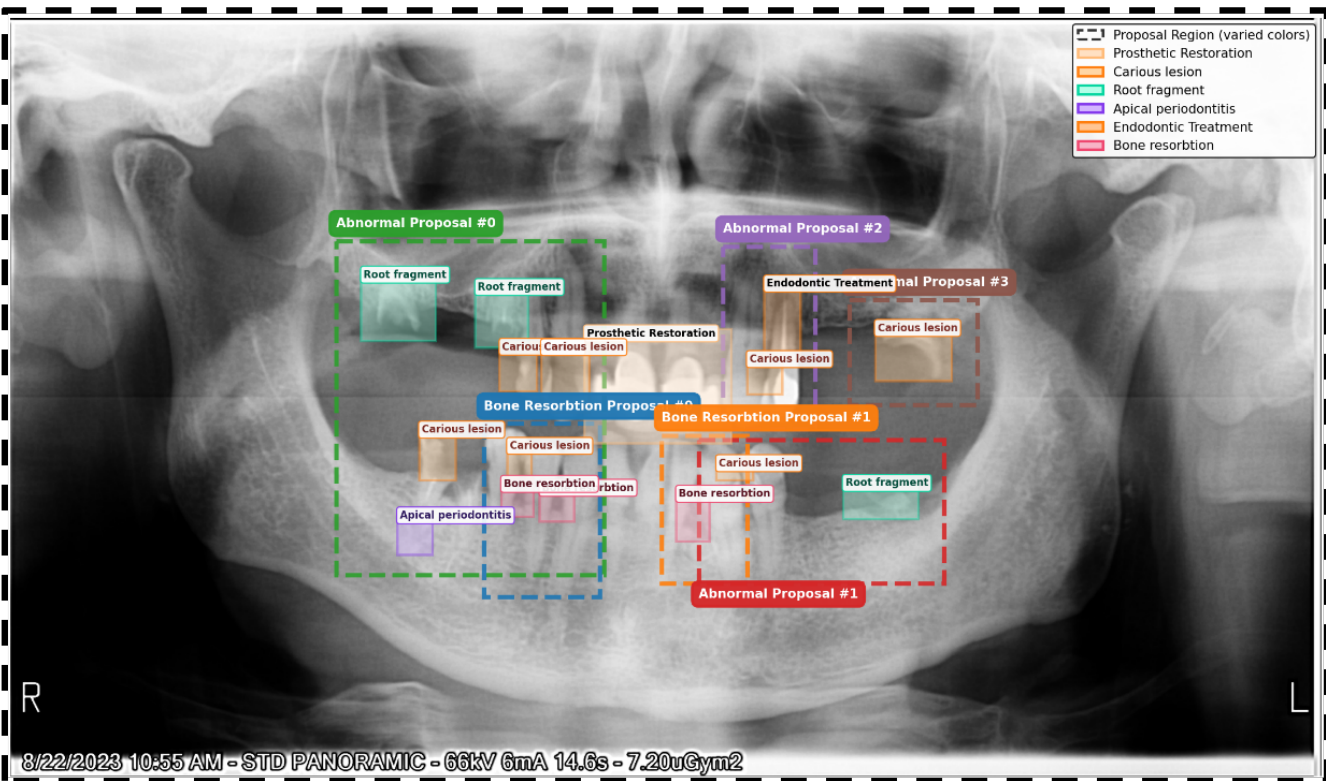
The region  $[0.44, 0.41, 0.55, 0.56]$  shows a prosthetic restoration. Carious lesions are present at teeth 13, 14, 24, 33, 45 and 46, and at the region  $[0.66, 0.40, 0.72, 0.48]$ . Root fragments are present at tooth 14 and in the regions  $[0.27, 0.33, 0.32, 0.43]$  and  $[0.64, 0.61, 0.69, 0.66]$ . Apical periodontitis is noted at tooth 46. Tooth 24 has endodontic treatment. Bone resorption is seen near teeth 32, 44 and 45; the image also suggests root resorption on the left side with adjacent bone loss that may correlate with these areas of bone resorption.
