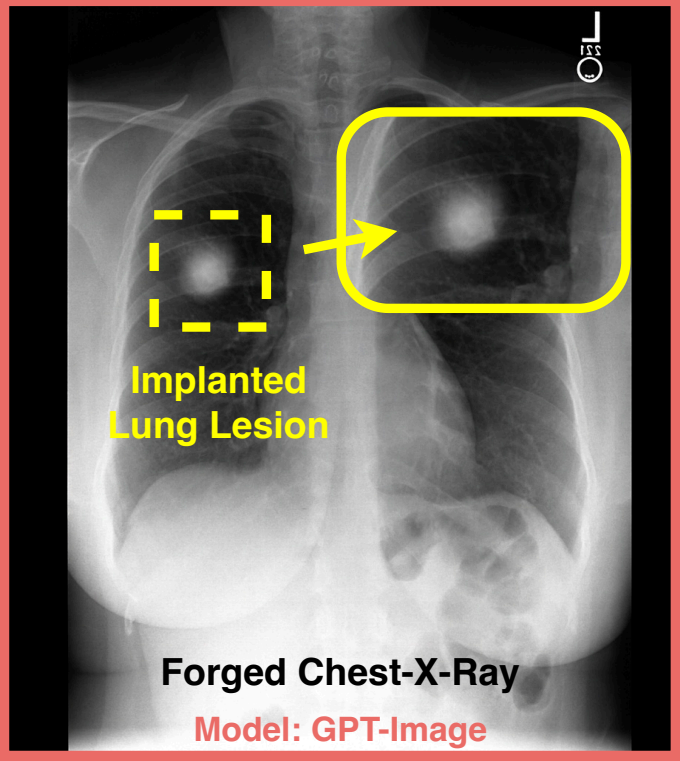
Based on a visual analysis, this image appears to be a **medically manipulated "deepfake"** (a synthetic lesion injection). Here is the breakdown of why it falls into this category: The underlying image—the rib cage, the spine, the heart shadow, the diaphragm, and the soft tissues—appears to be a legitimate, real chest X-ray of a human patient. The suspicious element is the bright, round white spot (nodule) in the right mid-lung zone (on the viewer's left).

2: **"Visual Cues"**: The nodule looks "too perfect." It is perfectly circular and has a fuzzy, glowing quality that differs slightly in texture from the surrounding lung markings. While real tumors (like "cannonball metastases") can be round, this specific look is characteristic of synthetic datasets used to train AI models to detect cancer.

<think> Okay, let's see. I am starting to analyze whether this image is a deepfake: <description>This **is a posteroanterior (PA) chest X-ray of an adult female**. A prominent, well-circumscribed, round, and dense nodule is visible in the right upper lung zone</description>. I have identified **the suspect deepfake area** at: **"deepfake"x1="258" y1="316" x2="333" y2="402"**. Now I am going to perform a detailed analysis of this suspect region. In my observation, the evidence for deepfake is: <evidence>**The "Sticker" Artifact:** The nodule has an unnaturally sharp and smooth border, lacking the gradual transition zone expected in biological tissue. It appears as if it were **digitally pasted onto the lung parenchyma**. **Mass Effect Absence:** A real mass of this size would physically displace or compress adjacent structures. However, the surrounding lung markings (vessels and bronchi) appear to pass uninterrupted through the nodule, which is biologically impossible. The nodule does not obscure or push these structures. **Inconsistent Density and Texture:** The nodule has a uniform, homogenous density that is inconsistent with the texture of the surrounding lung tissue. Furthermore, the lung markings behind the nodule are completely absent, which is unusual for a lesion of this nature</evidence>. Based on these findings, I conclude that: <conclusion>The presence of a "sticker-like" lesion that violates the principles of mass effect and anatomical superposition confirms that this image is a deepfake</conclusion>.

**Anatomical Consistency:** The image shows typical chest X - ray features: Clear visualization of bony structures (ribs, clavicles, spine). Normal lung fields with expected air - filled (darker) and tissue - dense (lighter) patterns. Proper positioning of the heart, diaphragm, and other thoracic structures.

Technical Markers: The "L" (indicating the left side of the patient) and other standard radiographic markers (e.g., the circular symbol with "321") are consistent with clinical X - ray protocols.
