8<sup>TH</sup> INTERNATIONAL CONFERENCE ON MICRO-PATTERN GASEOUS DETECTORS

## Development of a high-rate capable DLC-RPC based on a current evacuation pattern

**ABSTRACT:** A Resistive Plate Chamber using Diamond-Like Carbon electrodes (DLC-RPC) has been developed as a background tagging detector in the MEG II experiment. The DLC-RPC is planned to be installed in a high-intensity and low-momentum muon beam. This detector is required to have a detection efficiency above 90 % with four active gaps in the muon beam due to the limitation of the material budget. In such an environment, the high current flowing through the resistive electrodes causes a voltage drop, which reduces the performance of the DLC-RPC. This voltage drop can be suppressed by implementing a current evacuation pattern, though discharges are more likely to occur near the pattern. Therefore the pattern must be covered by a protection cover made of an insulator. In this study, electrode samples with a current evacuation pattern and different widths of protection cover (0.2 mm and 0.8 mm) have been produced, and their performance and stability were measured. The detection efficiency of a single-gap chamber for  $\bet

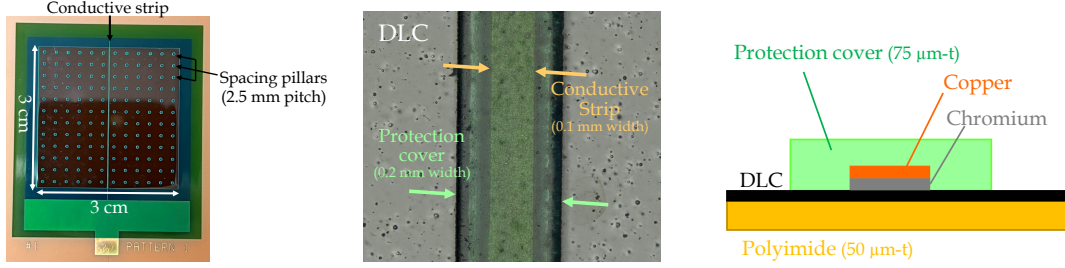
Figure 1 shows the DLC-RPC electrode with the current evacuation pattern. DLC was directly sputtered onto the 50  $\mu$ m thick polyimide film. The conductive current evacuation pattern was implemented on the DLC layer and covered with a protection layer whose material is the same as the pillars. This pattern was formed by the lift-off process. Chromium was sputtered onto the DLC layer, followed by copper sputtering onto the chromium layer. This sandwich structure is motivated by the good adherence of chromium with DLC. This electrode is made with pillars of  $\sim 365$   $\mu$ m thickness, 0.6 mm diameter and 2.5 mm pitch, with a current evacuation pattern of

**Figure 1.** Pictures and a schematic of the DLC-RPC electrode with the current evacuation pattern. (Left) Overview. (Center) Enlarged view of the strip structure. (Right) Cross-section of the strip structure.

0.1 mm width, and a  $3 \times 3 \text{ cm}^2$  of active region. The variation of the pillar thickness was measured to be below  $10 \text{ }\mu\text{m}$ . The surface resistivity of DLC was measured to be  $6 - 15 \text{ M}\Omega/\text{sq}$ . Different electrode samples with 0.2 mm and 0.8 mm widths of the protection cover were tested to investigate the width needed to avoid discharge. According to the results and discussions in Reference [1], the voltage drop will be down to 100 V at the expected operation voltage in the muon beam for this configuration.

In this study, we measured the detection efficiency for  $\beta$ -rays and assessed the stability of the DLC-RPC. An experimental setup is shown in Figure 2. The electrode shown in Figure 1 was used as an anode electrode. A bare DLC sputtered polyimide was used as a cathode electrode, in which the surface resistivity of DLC was measured to be  $10 - 15 \text{ M}\Omega/\text{sq}$ . These electrodes were placed facing each other to form the DLC-RPC gas gap. This gap was filled with  $\text{C}_2\text{H}_2\text{F}_4 / \text{SF}_6 / \text{iC}_4\text{H}_{10}$  (94/1/5). Trigger counter signals were fed directly into a DRS4 waveform digitizer [4], and detection signals of the DLC-RPC were induced in an aluminum strip outside the gas gap, amplified by 38 dB, and then fed into the DRS4. In this measurement, a detection efficiency of the DLC-RPC was calculated as the percentage of events in which the DLC-RPC signal exceeded a 20 mV signal threshold, which corresponds to a 25 fC charge threshold in the readout strip among events triggered by a trigger counter.

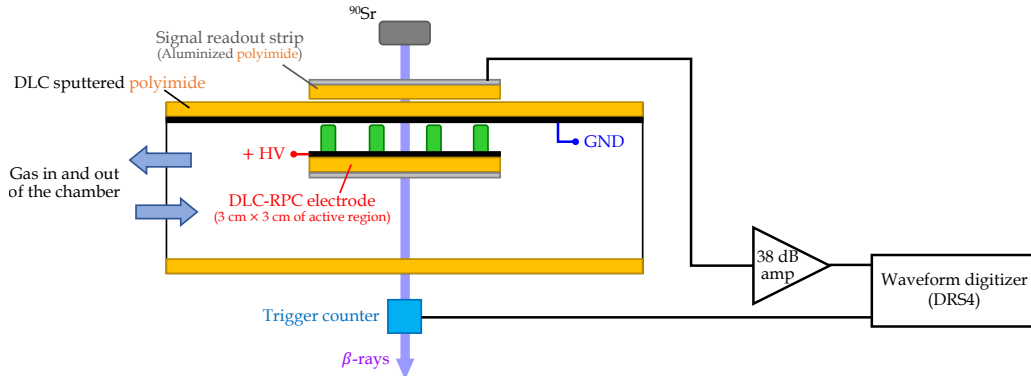
**Figure 2.** Experimental setup. The DLC-RPC electrode is placed in a chamber filled with working gas.

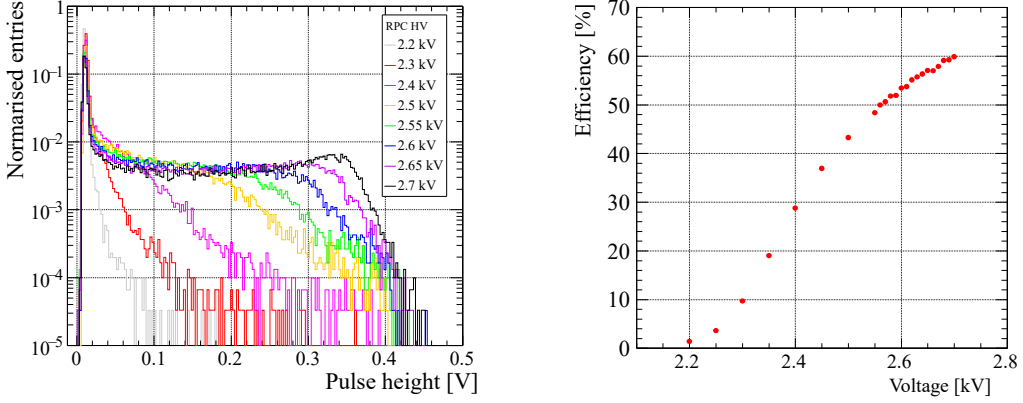
Figure 3 shows the performance of the DLC-RPC for  $\beta$ -rays from a  $^{90}\text{Sr}$  source. In this measurement, the  $\beta$ -rays were collimated to a beam of 2 mm diameter, which was irradiated far from the conductive pattern to avoid instability due to the strip structure. This instability is attributed to an excessive gas avalanche process caused by the distortion of an electric field caused by the protection cover and a charging up of it, as well as a quenching capability against discharges is low due to the short distance over which the charge flows through the resistive layer. The measured hit rate was  $O(1 \text{ kHz})$ . The  $n$ -gaps efficiency can be estimated with the single-gap efficiency  $\epsilon_1$  by  $\epsilon_n = 1 - (1 - \epsilon_1)^n$ . The measured efficiency of 60 % at 2.75 kV is enough to reach a target efficiency of 90 % with four gaps. A minimum single-layer efficiency to obtain this target efficiency is about 45 %, which requires an operating voltage of around 2.5 kV from the right side of Figure 3. Since the operating voltage reached 150 V higher than this minimum required voltage, we can expect that the detection efficiency will not fall below 45 % (corresponds to 90 % efficiency with four layers) even with a 100 V voltage drop in the muon beam as described in Section 2.

**Figure 3.** Performance of the DLC-RPC for the  $\beta$ -rays. (Left) Pulse height spectra of the DLC-RPC triggered by a trigger counter. (Right) Detection efficiency.

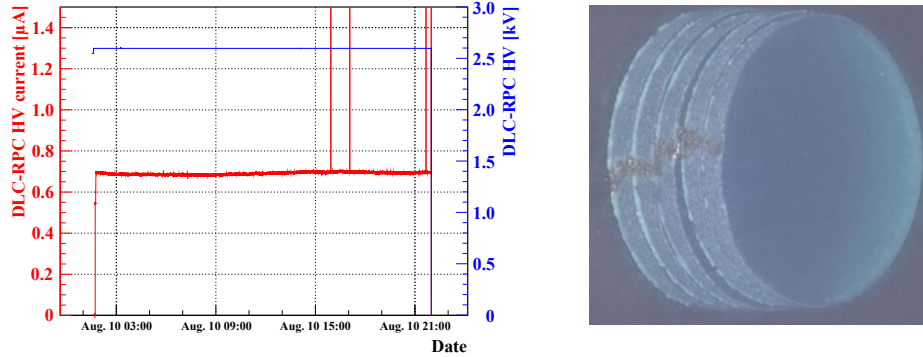
Finally, the long-term stability was assessed. The whole region was continually irradiated with non-collimated  $\beta$ -rays with a hit rate of  $O(100 \text{ kHz})$ . The left plot in Figure 4 shows the operation history. The operating voltage was set to 2.6 kV, which is 30 – 50 V lower than the target voltage. Discharges suddenly occurred after about 14 hours, and the DLC-RPC eventually tripped

after 20 hours. The discharge created a current path on one of the pillars (the right in Figure 4) and prevented the operation of the chamber. Furthermore, higher hit rates tended to make the chamber more unstable, but we need further investigation in this dependence.

**Figure 4.** Status of the long-term operation. (Left) Operation voltage and measured current versus time. (Right) Picture of the damaged spacing pillar.

Summarizing, the measured performance looks promising for the prototype in terms of the requirement for detection efficiency. On the other hand, the long-term instability, caused by materials inside gaps, is problematic in the MEG II experiment. Since low surface resistivity can cause such instability, it should be adjusted to safer ranges (above  $20 \text{ M}\Omega/\text{sq}$ ). Besides, the avalanche charge could gradually burn the polymer in the pillars, eventually leading to the discharges as shown in Figure 4. We need further investigation into causes and solutions to suppress damage to the material. Another scenario that caused instability is an ionic contamination of residuals from a resist-dissolving process. As mentioned in Section 1, spacing pillars were formed by photolithographic technology. In this process, the resist is dissolved with a chemical solution after curing by exposure, and a residue from the dissolving process could become a current pathway. We will plan to add an electrode cleaning process to address this contamination.
